GARFIELD PARK CULTURAL LANDSCAPE REPORT

Chapter IV: Existing Conditions

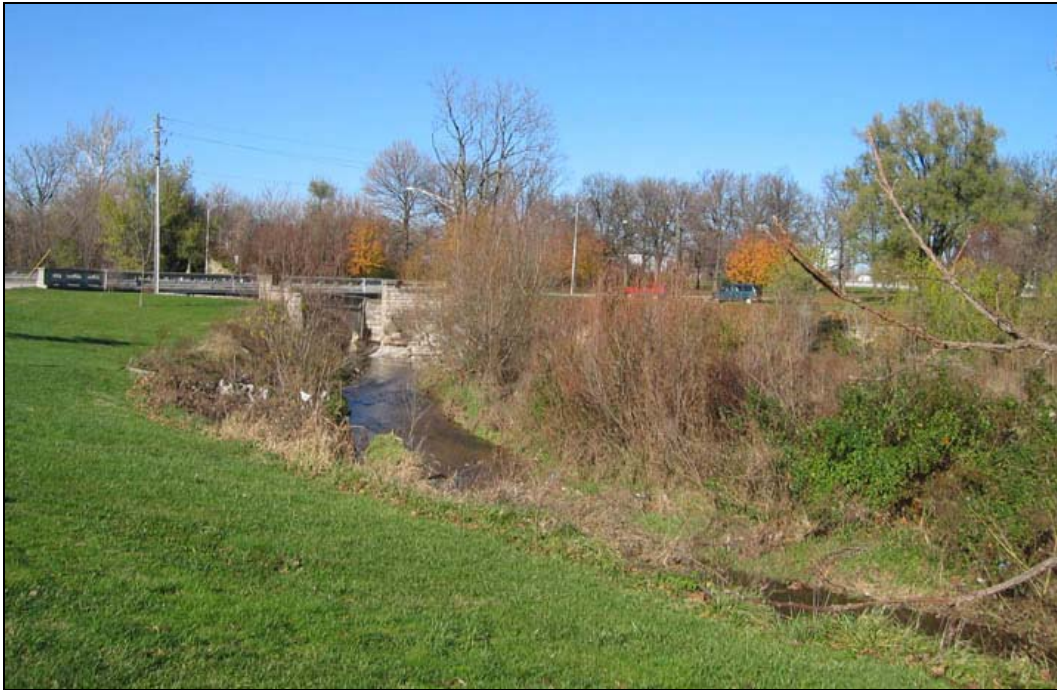
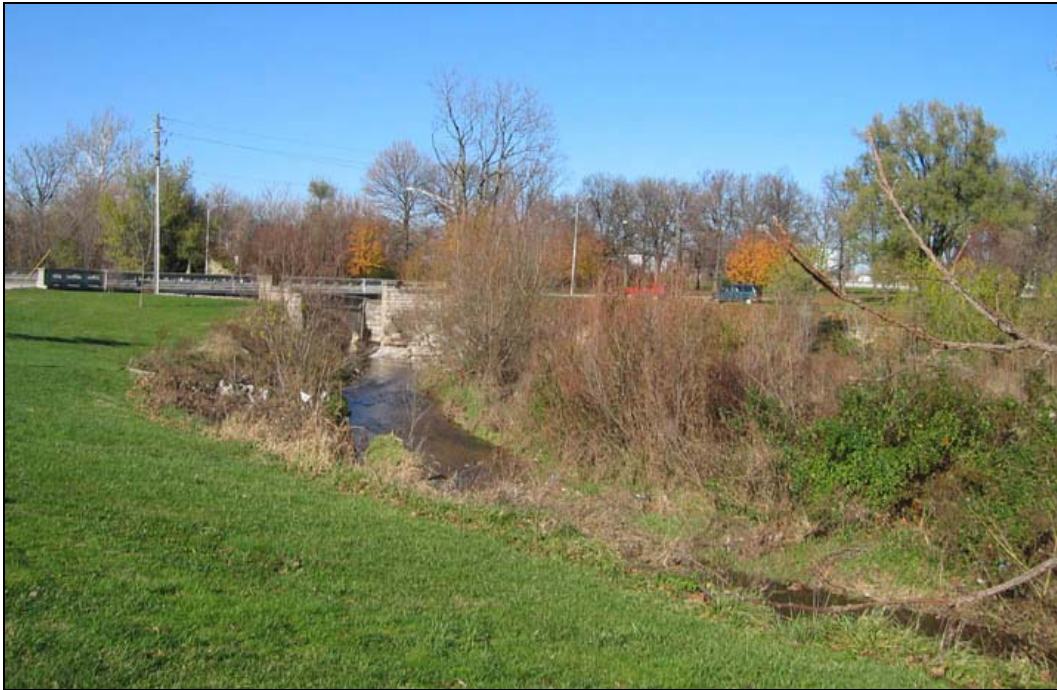
Figure IV.11 A curving portion of Bean Creek with early successional and invasive species vegetating the banks. (R-IV-119_1950.jpg HL)

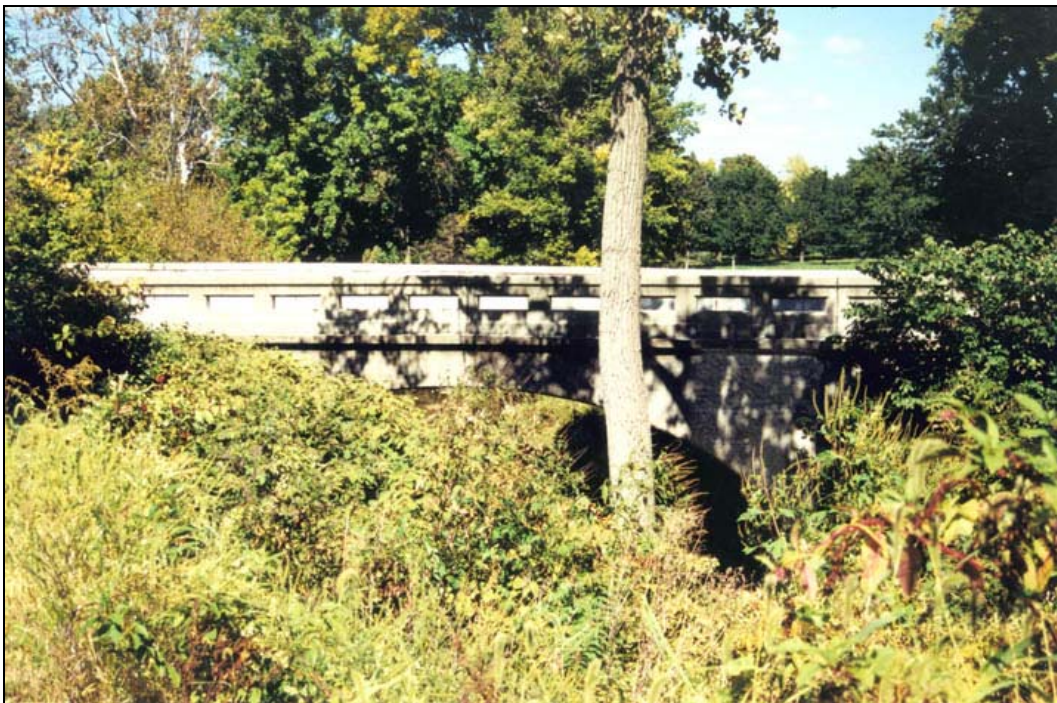
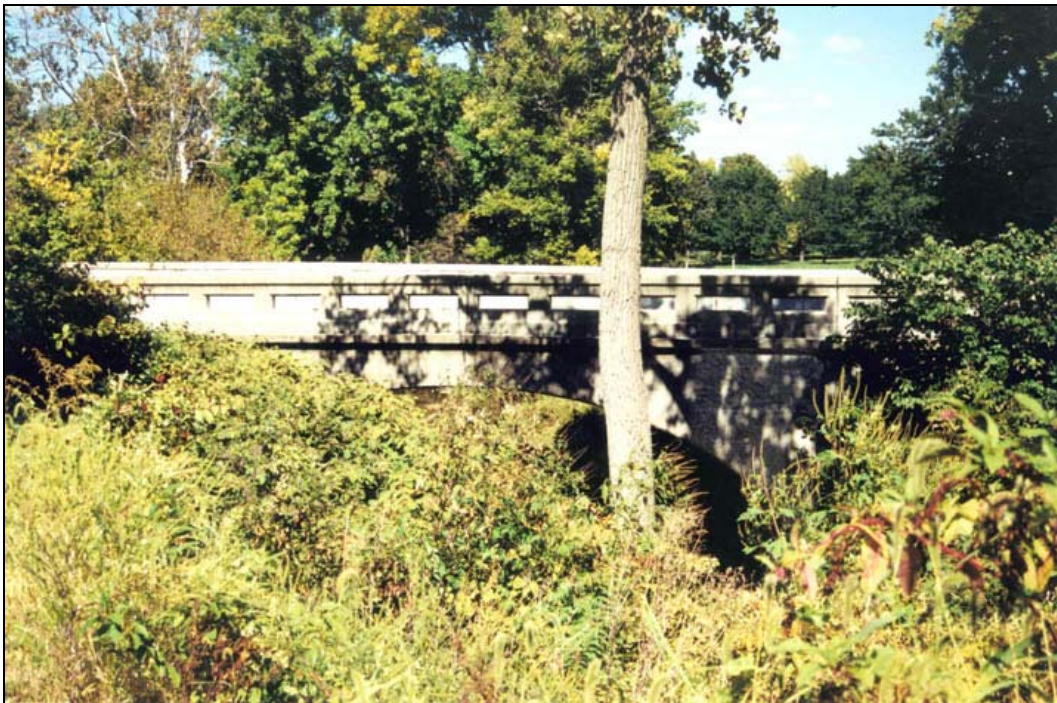
Figure IV.12 1923 filled-spandrel arch bridge on Pagoda Drive spanning a densely vegetated section of Bean Creek. (R-IV-17-HL.jpg)

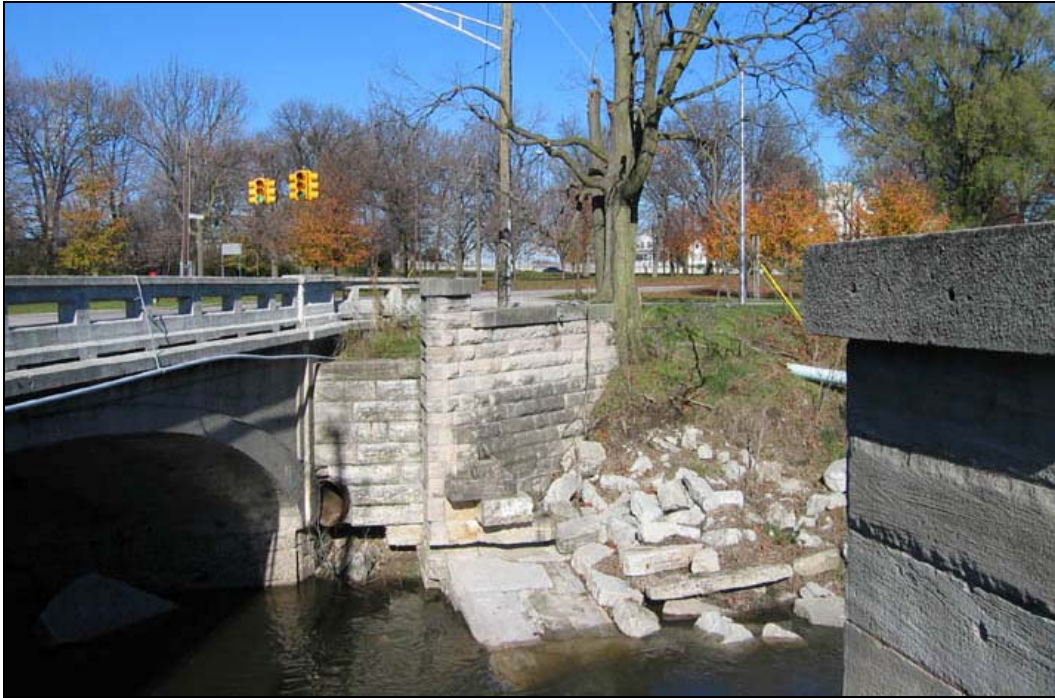
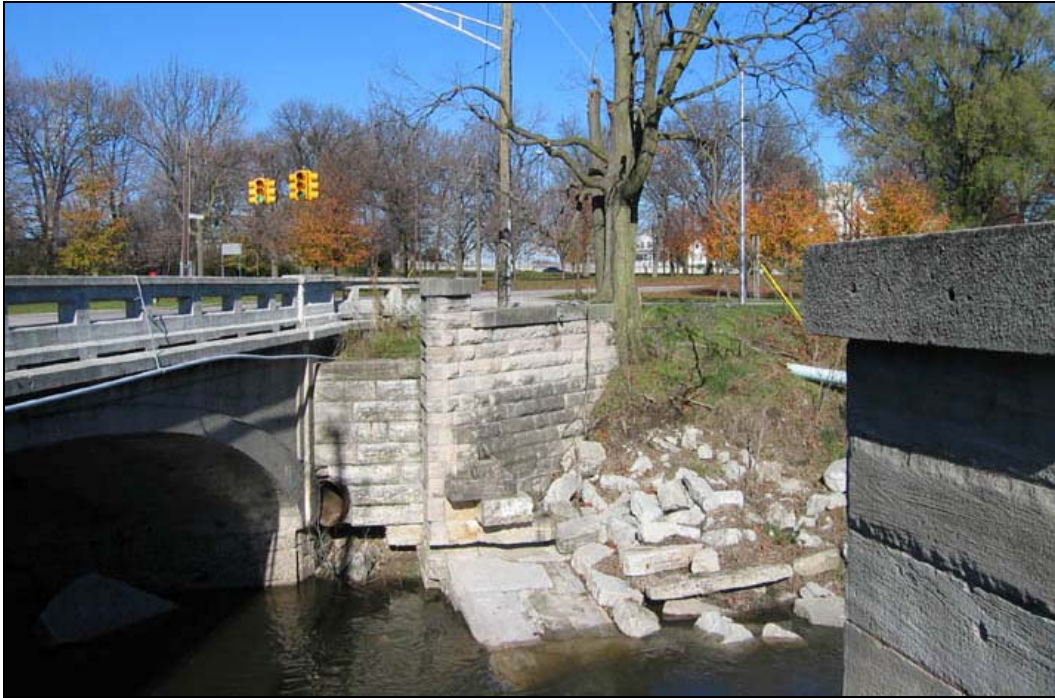
Figure IV.13 Rebuilt 1928 filled-spandrel arch bridge with original stone wing walls and rectilinear concrete railings crossing Pleasant Run. Remnants of the old dam are visible in lower center of photograph. (R-IV-119_1954.jpg)

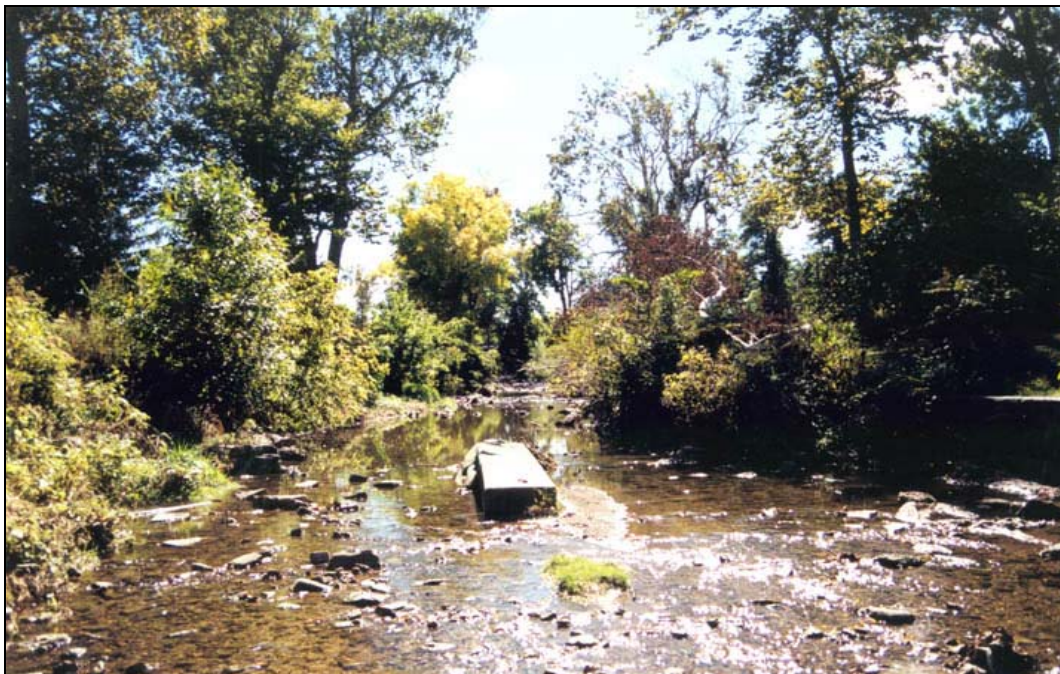
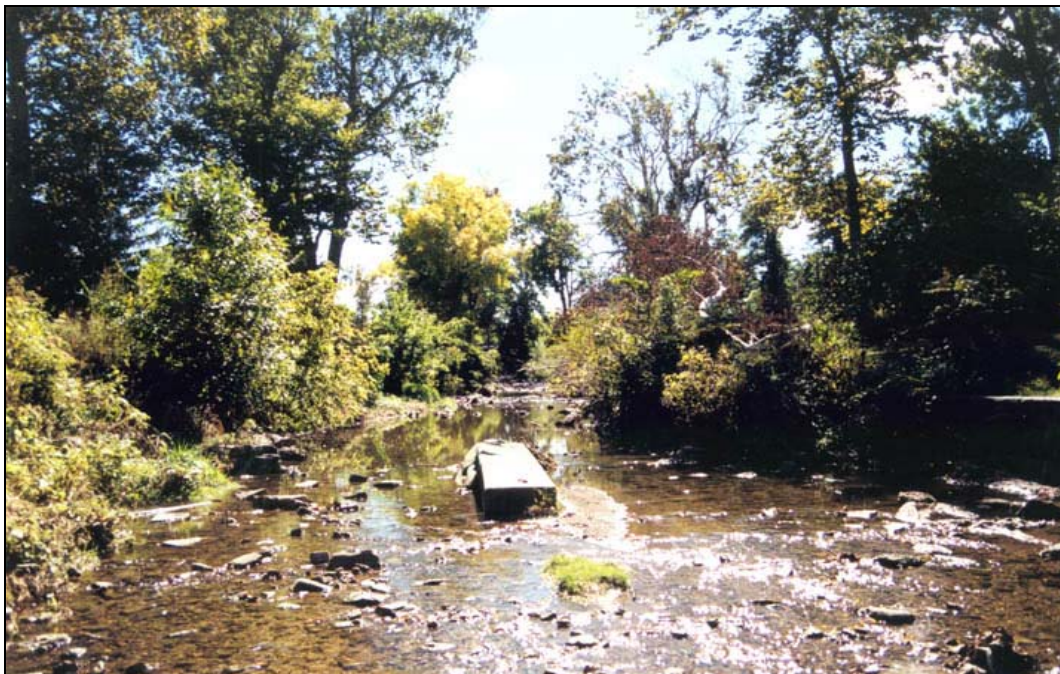
Figure IV.14 Foundations of a former pedestrian bridge are visible in Bean Creek on the west side of the Sunken Gardens. (R-IV-23-HL.jpg)
