GARFIELD PARK CULTURAL LANDSCAPE REPORT

Chapter III: 1930s As-Built Character

A. INTRODUCTION

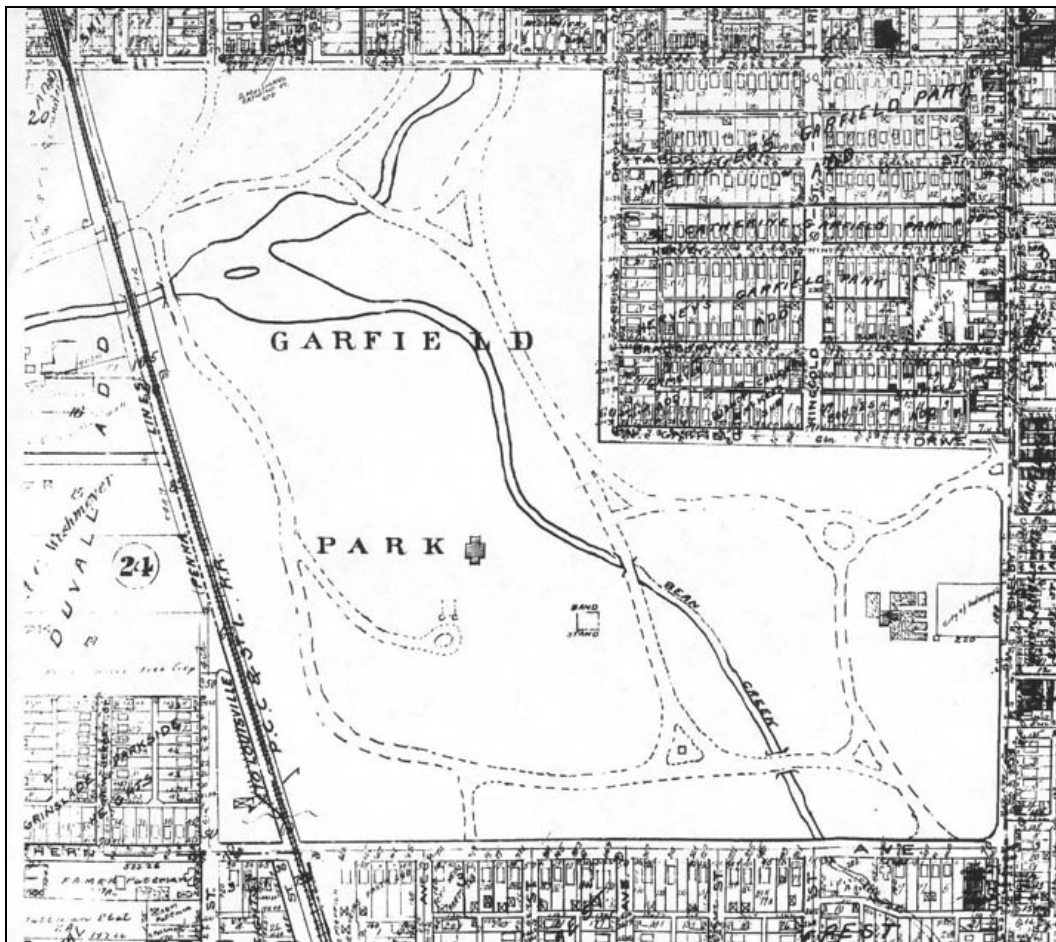
Figure III.1 Baist Map of Indianapolis, 1941, showing park drives, streams, structures, and surrounding neighborhood with small residential lots. (R-Baist1941.jpg)

The extensive system of bike and foot paths afforded a multitude of possible avenues to experience the park. As seen in Figure III.1 and the 1937 aerial photograph, walks from the adjoining neighborhoods extended into the park landscape. The curvilinear system of paths followed natural alignments along streambeds and through groves of trees creating secondary loops within the park. The walks gave access to significant landscape features and park buildings, with vistas framed by vegetation. The Board of Park Commissioners Annual Reports detail the lengths of walks constructed of stone screenings each year. Figures II.13 and II.23 in Chapter II show people posing on the bridges that were destinations in their own right.

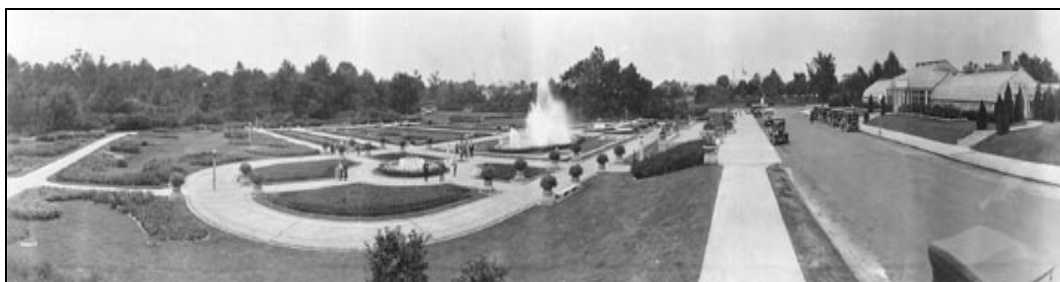
Figure III.2 Panoramic view of the Conservatory and Sunken Gardens in 1923 clearly showing the three levels and symmetrical arrangement of steps, walks, beds, turf, and fountains. (R-PO130_56061-F ISL)

Plaza Drive, connecting Pagoda Drive with Conservatory Drive, runs north-south between the Conservatory and Sunken Gardens, seen in Figures III.2 and III.4, and in Chapter II, Figure II.15, giving patrons a view from their vehicles across the Gardens. Visitors to the Conservatory and Sunken Gardens can park along the wide drive and stroll into the Gardens or Conservatory. In the late 1930s views into the Sunken Gardens from the adjacent drives are enlarged by the removal of shrubbery so recreational motorists can get a better view at faster speeds. Plaza Drive intersects Pagoda Drive with a triangular grassy island at its southern end and Pagoda Drive enters the park from Southern Avenue with a second triangle.

The terraced Overlook makes a formal entry to the Sunken Gardens below with a progression of descending levels as seen in Figures III.2 and III.5. The concrete of the terrace visually links to the decorative benches, lampposts and planters in the Gardens. Bedford stone bowls (now called Prairie-style planters) placed on the walls of the Overlook soften the lines of the terrace. Two sets of steps within the terrace or steps on either side give access to the Gardens.

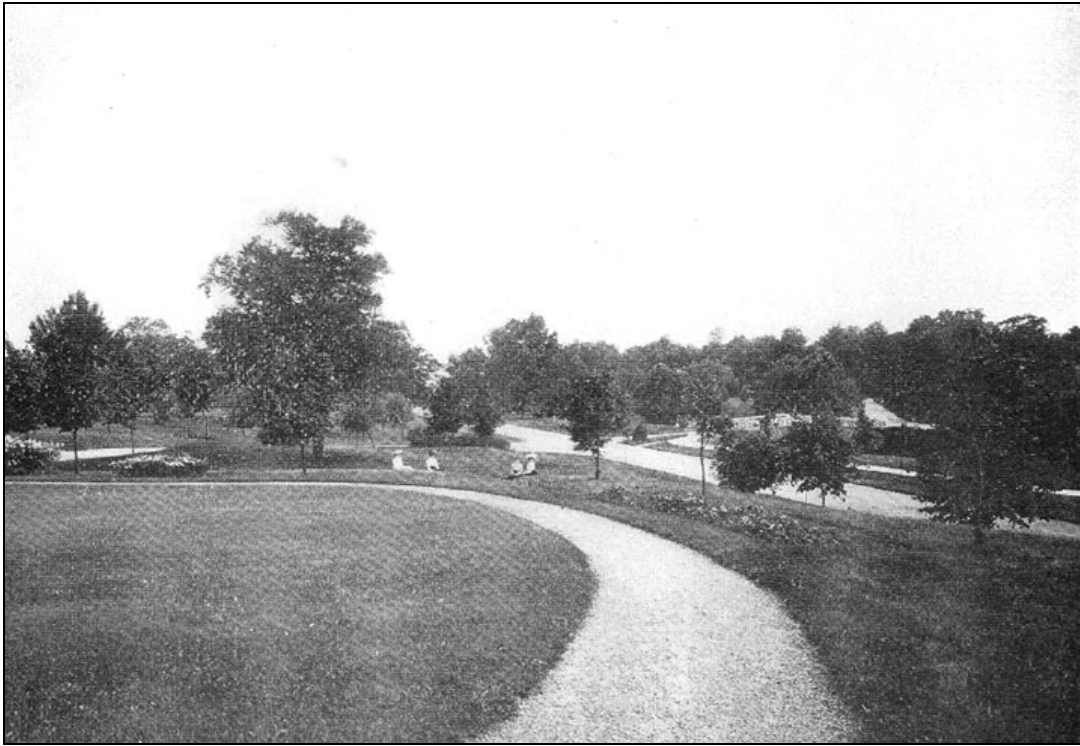
Figure III.3 A 1910 view of the sledding hill showing mown turf, paths, drive, flowerbed, and individual tree plantings. (R-6-24 1910AR.jpg ISL)

The spatial organization within the park was established by existing topography and natural features of the site. The terrain consisted of the sinuous streambeds of Bean Creek and Pleasant Run, their flood plains, with the elevated plateaus offering prospect views within the park. An elevated ridge of land, one of the few in the city, extended west into the northeast quadrant of the park. On the north, east, and south sides the residential areas had views into the park, and formed visual boundaries from the park. Views within the park were generally open, framed by trees and flowering shrubs, and punctuated by flower beds as seen in Figure III.3.

As seen in the 1937 and 1941 aerial photographs and period ground photograph, the park vegetation consisted of dense woodlands in the south and southwest area of the park. More open woods defined the edges of Bean Creek extending to the groves at the northwest corner of the park. Trees lined the drives and open grass areas were interspersed with single and clustered trees. Groups of evergreens were planted on slopes. The Annual Reports indicate large numbers of young trees and shrubs being planted in the park, creating borders for the park, and highlighting the entrance areas. Views of the streams and lake were framed by groups of trees that gave welcome shade in the summer. The Sunken Gardens were well known for their Victorian-style ornamental plantings, seen in Figures III.2 and III.5, and photographs show flowerbeds in other parts of the park, as seen in Figure III. 3.

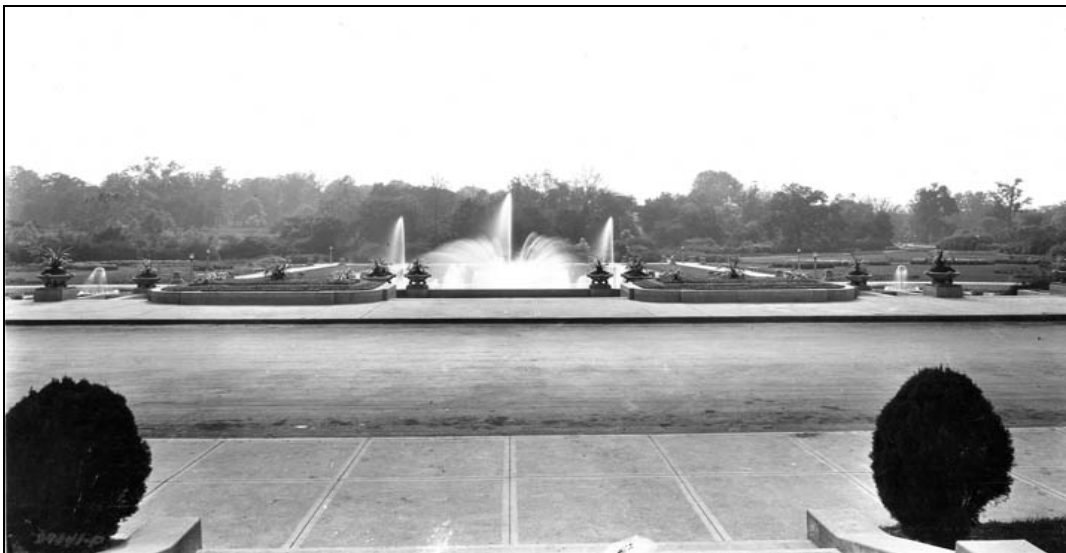
Figure III.4 View west from Conservatory Drive and the Overlook to the Sunken Gardens in 1924. (R-PO130_87105-F_SG.jpg IHS)

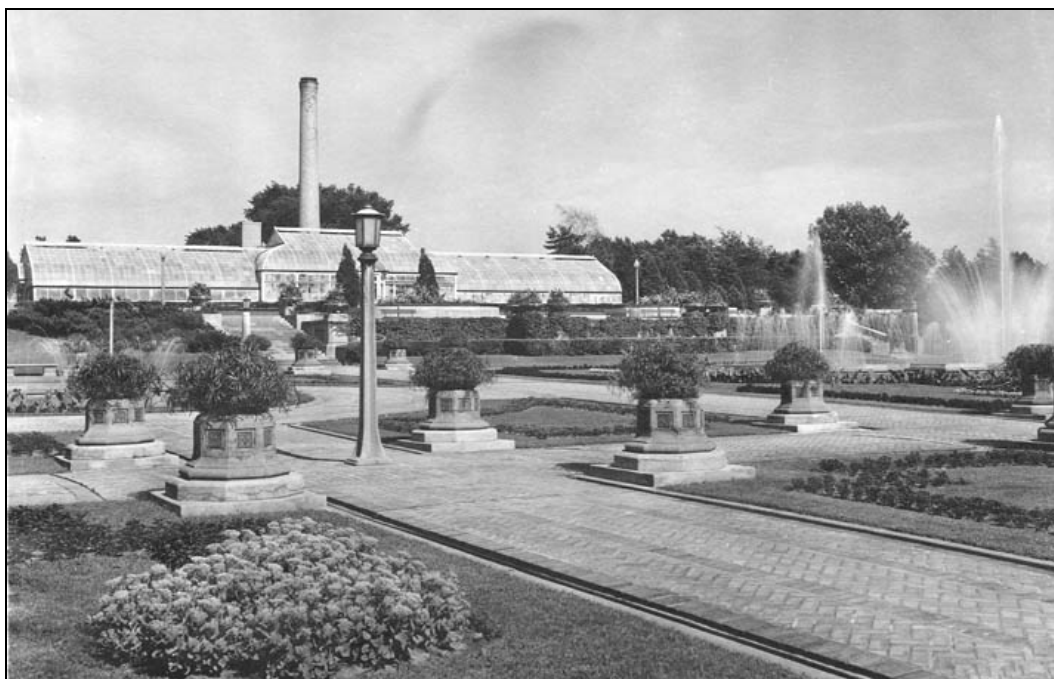
Figure III.5 View across the Sunken Gardens toward the Conservatory showing the full vocabulary of brick walks, planters, and light posts in Arts and Crafts style. (R-PO130-23820F-E-SG.jpg IHS)

The Conservatory is located on a rise above the terraced Overlook and symmetrical Sunken Gardens below (Figures III.5 and III.6). The conservatory is a wood and steel truss structure containing approximately 20,000 square feet of glass panes. It is backed by a series of six greenhouses attached along its eastern side. Eight pairs of cement hotbeds are also located on the north side of the greenhouses.

the Sunken Gardens created a well-defined sense of place. Figure III.5 presents the aesthetic harmony of every aspect of the Sunken Gardens' designed elements. The unique composition, form, color, and texture, of the lampposts and urn planters are purposefully echoed in the design of the benches and the banded brick paving of the garden walks. The furnishings are placed symmetrically throughout the garden.

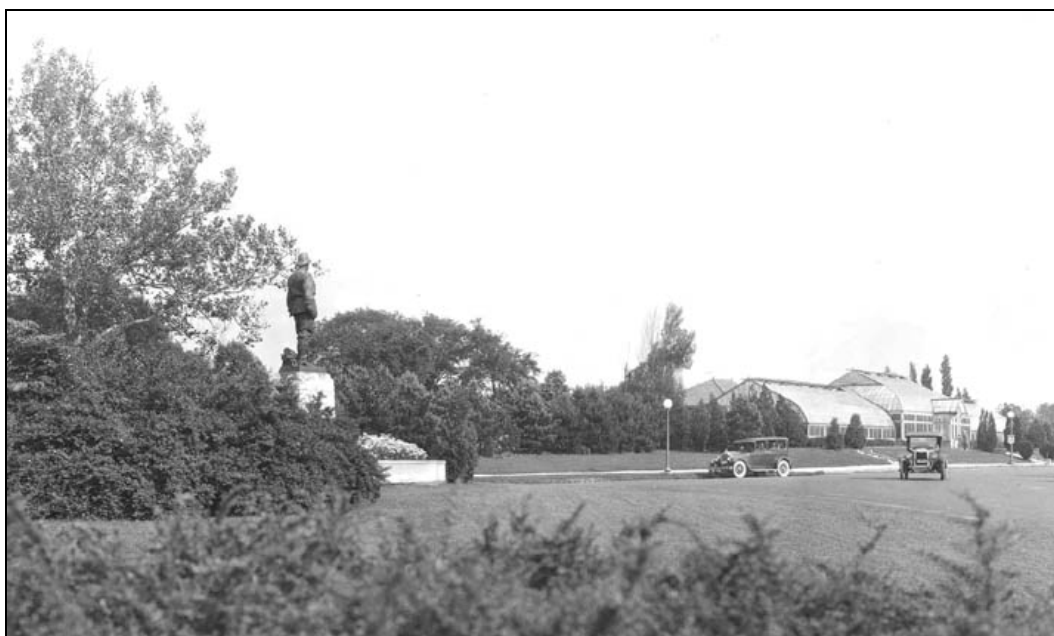
Figure III.6 Park landscape near General Lawton statue and the Conservatory showing gently sloping and open lawns, shrub masses, a sycamore tree, and an evergreen screen planting. (R-1.jpg IHPC)

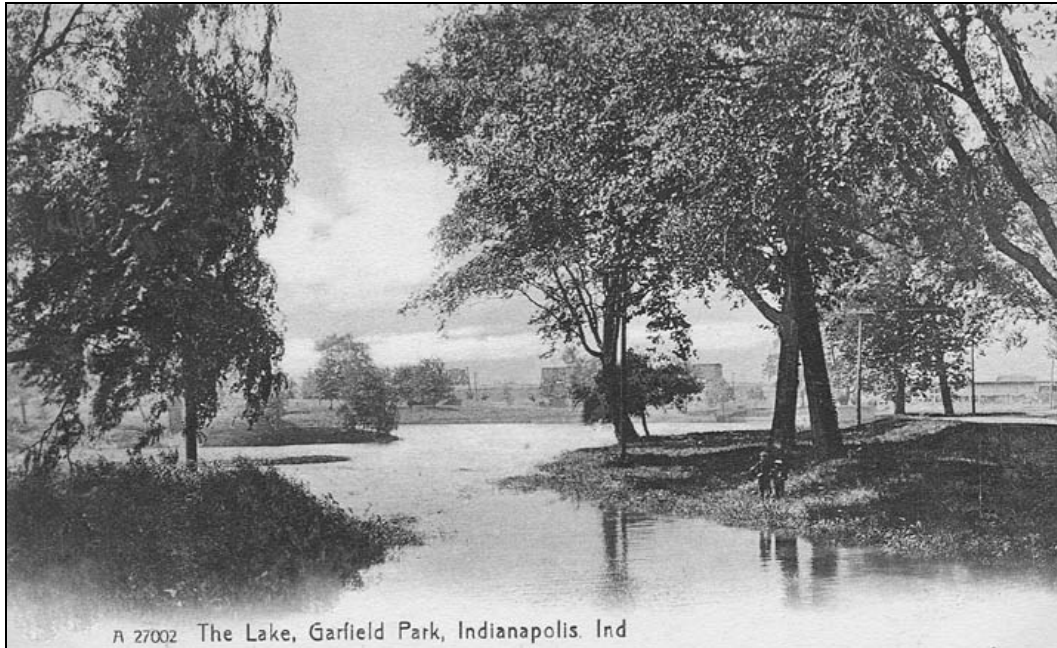
Figure III.8 View of the Lake at Garfield Park with grassy banks and mature trees. Two small boys and a train in the background are also visible. (R-PO391_A27002_Lake.jpg IHS)

Bean Creek, Pleasant Run, and the Lake are prominent features in the natural landscape of Garfield Park during the 1930s (AP1937). Pleasant Run is the larger waterway flowing northeast to southwest through the northern portion of Garfield Park, where the flow is dammed to form the Lake (Figure III.8). Pleasant Run is relatively straight and the channel is wider and deeper than Bean Creek due in part to previous re-grading of its banks and to the volume of water it carries. Bean Creek flows slowly northwest through the main body of Garfield Park joining Pleasant Run near the north Pagoda Drive Bridge. The waters of Pleasant Run and the Lake are highly visible along much of its course, and provided patrons of the park with recreational opportunities for boating, fishing and wading in summer and skating in winter (Figure III.8).

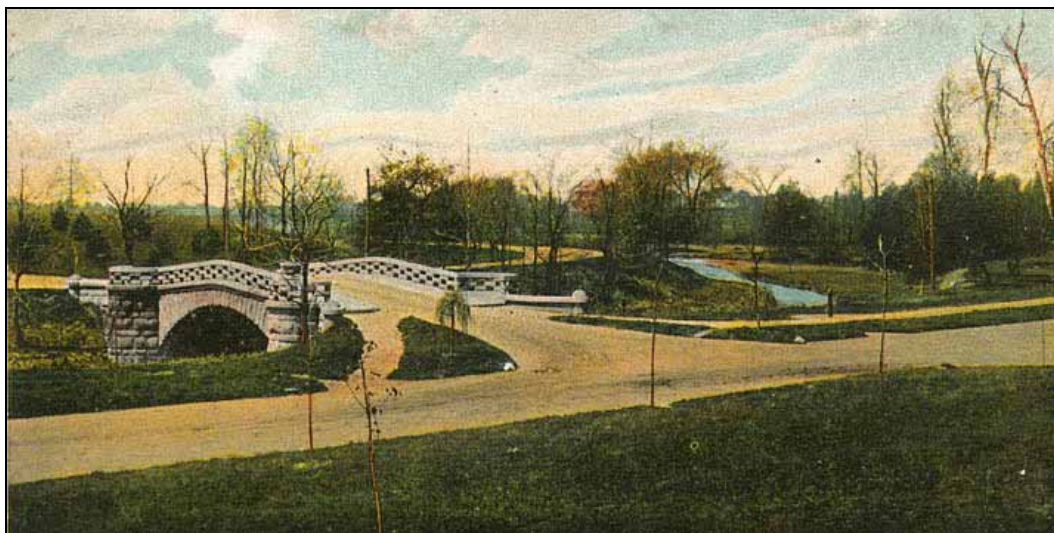
Figure III.10 Postcard view circa 1906 of park gravel drives, turf, young trees, and the distinctive bridge with block-and-void style railings on Bean Creek. (R-PO391_000_0100_Bridge_1906.jpg IHS)

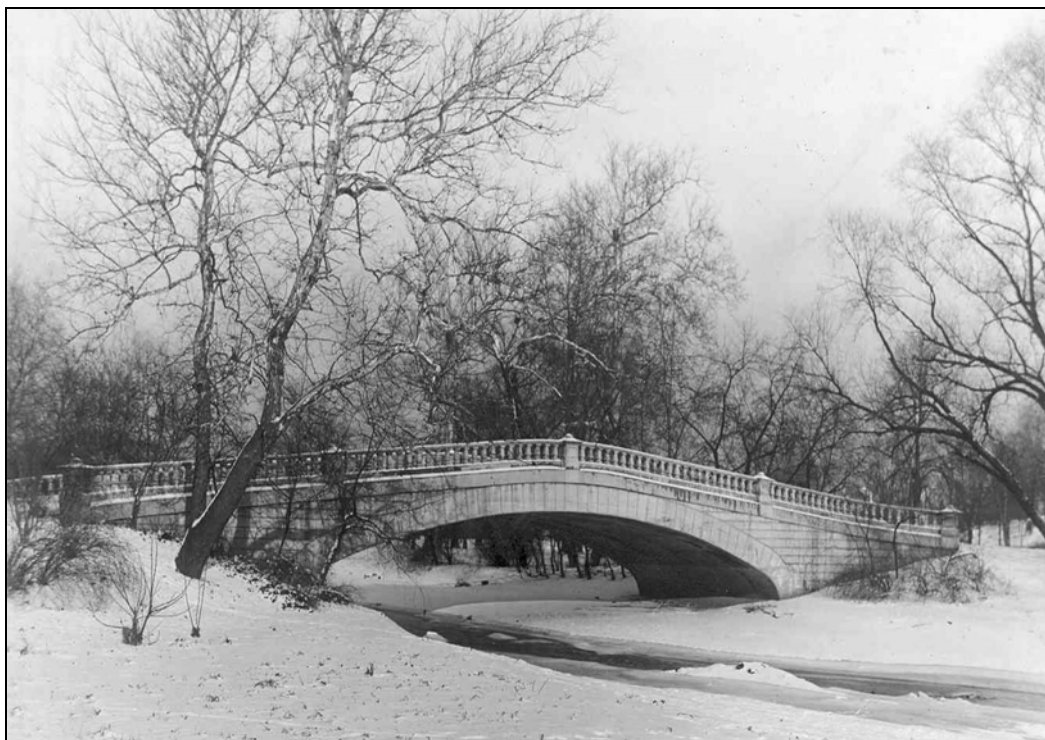
Figure III.11 Winter view of arc-en-panier style of the Pleasant Run bridge and wooded banks circa 1910. (R-7_bridge.jpg IHPC)

Within Unit 2b two bridges cross Pleasant Run. The northwestern bridge, near the baseball fields, is a 1928 filled spandrel arch bridge crossing Pleasant Run. The bridge is probably a Park Board design with spandrel walls decorated like stone and railings with rectangular openings. The second bridge at the northeastern entry of Central Drive is also a stone-faced filled spandrel arch bridge of 1927 Park Board design with bush-hammered, rectangular, decorative coffering (Figure III.11).

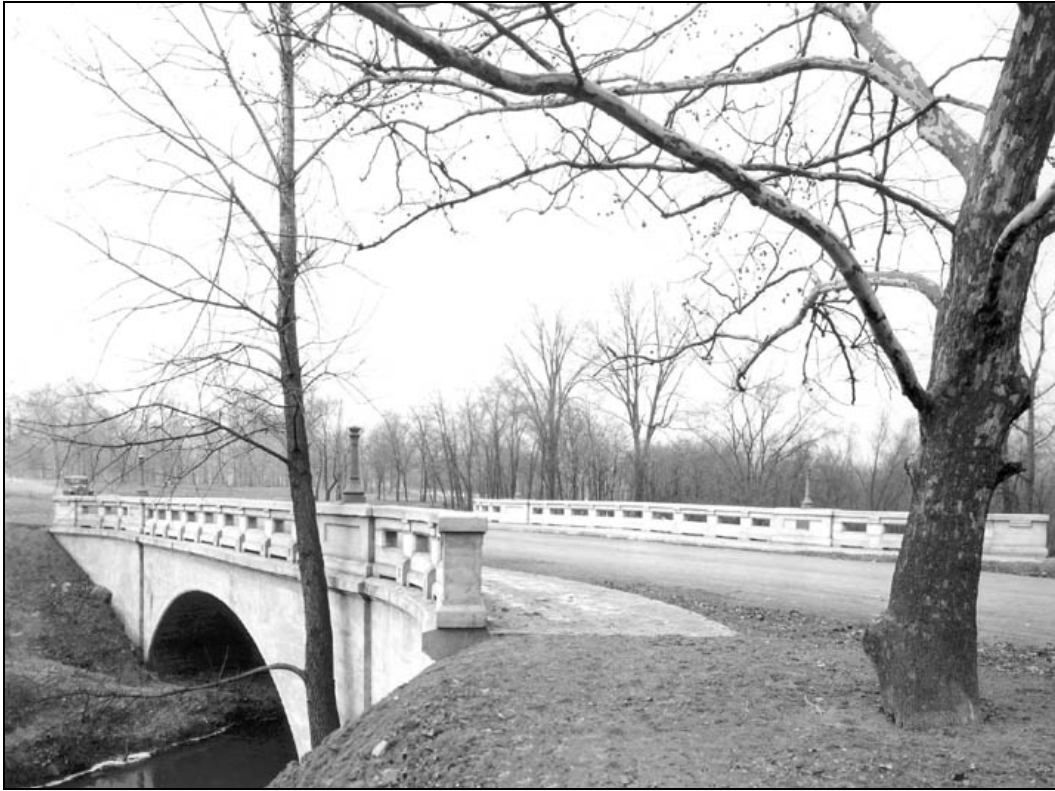
Figure III.12 View of the reinforced concrete Pagoda Drive bridge built in 1923, with open turf slopes and two trees; the larger one is a native sycamore. (R-8_sbridge.jpg IHPC)

Structures within Unit 2a include the bridges crossing Bean Creek at Pagoda Drive and Southern Avenue, built of reinforced concrete, which was a new form of construction at the time. Southern Avenue crosses Bean Creek on a filled spandrel arch bridge. The bridge has stone-faced rails with diamond-shaped openings and dates from 1907. The Pagoda Drive spandrel arch bridge, built in 1923 to Park Board design, has railings with rectangular openings (Figure III.12). A rustic pedestrian bridge is also located between unit 2a and the Sunken Gardens.

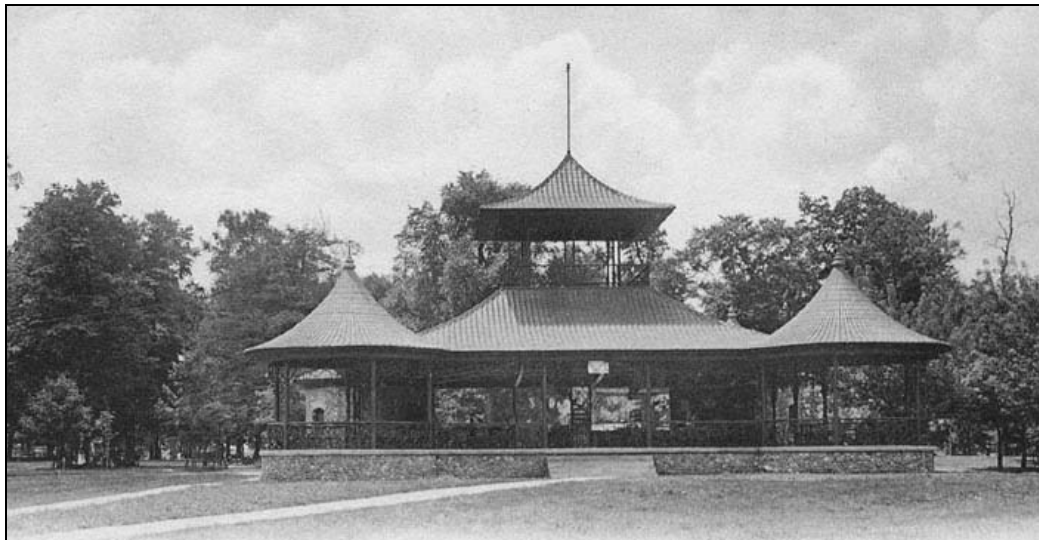
Figure III.13 View of oriental style Pagoda built in 1903 showing cobblestone structure, articulated roofs, iron railing, open turf, and background trees. (R-PO391_A27004_pagoda.jpg IHS)

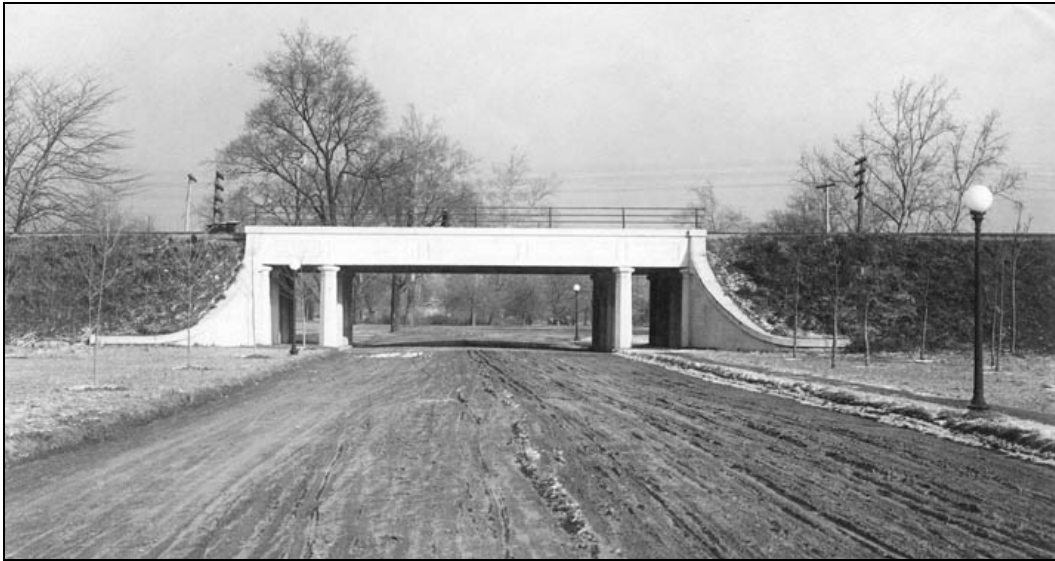
Figure III.14 The subway provided vehicular and pedestrian access through the railroad embankment. (R-LP0008_13260_subway.jpg IHS)

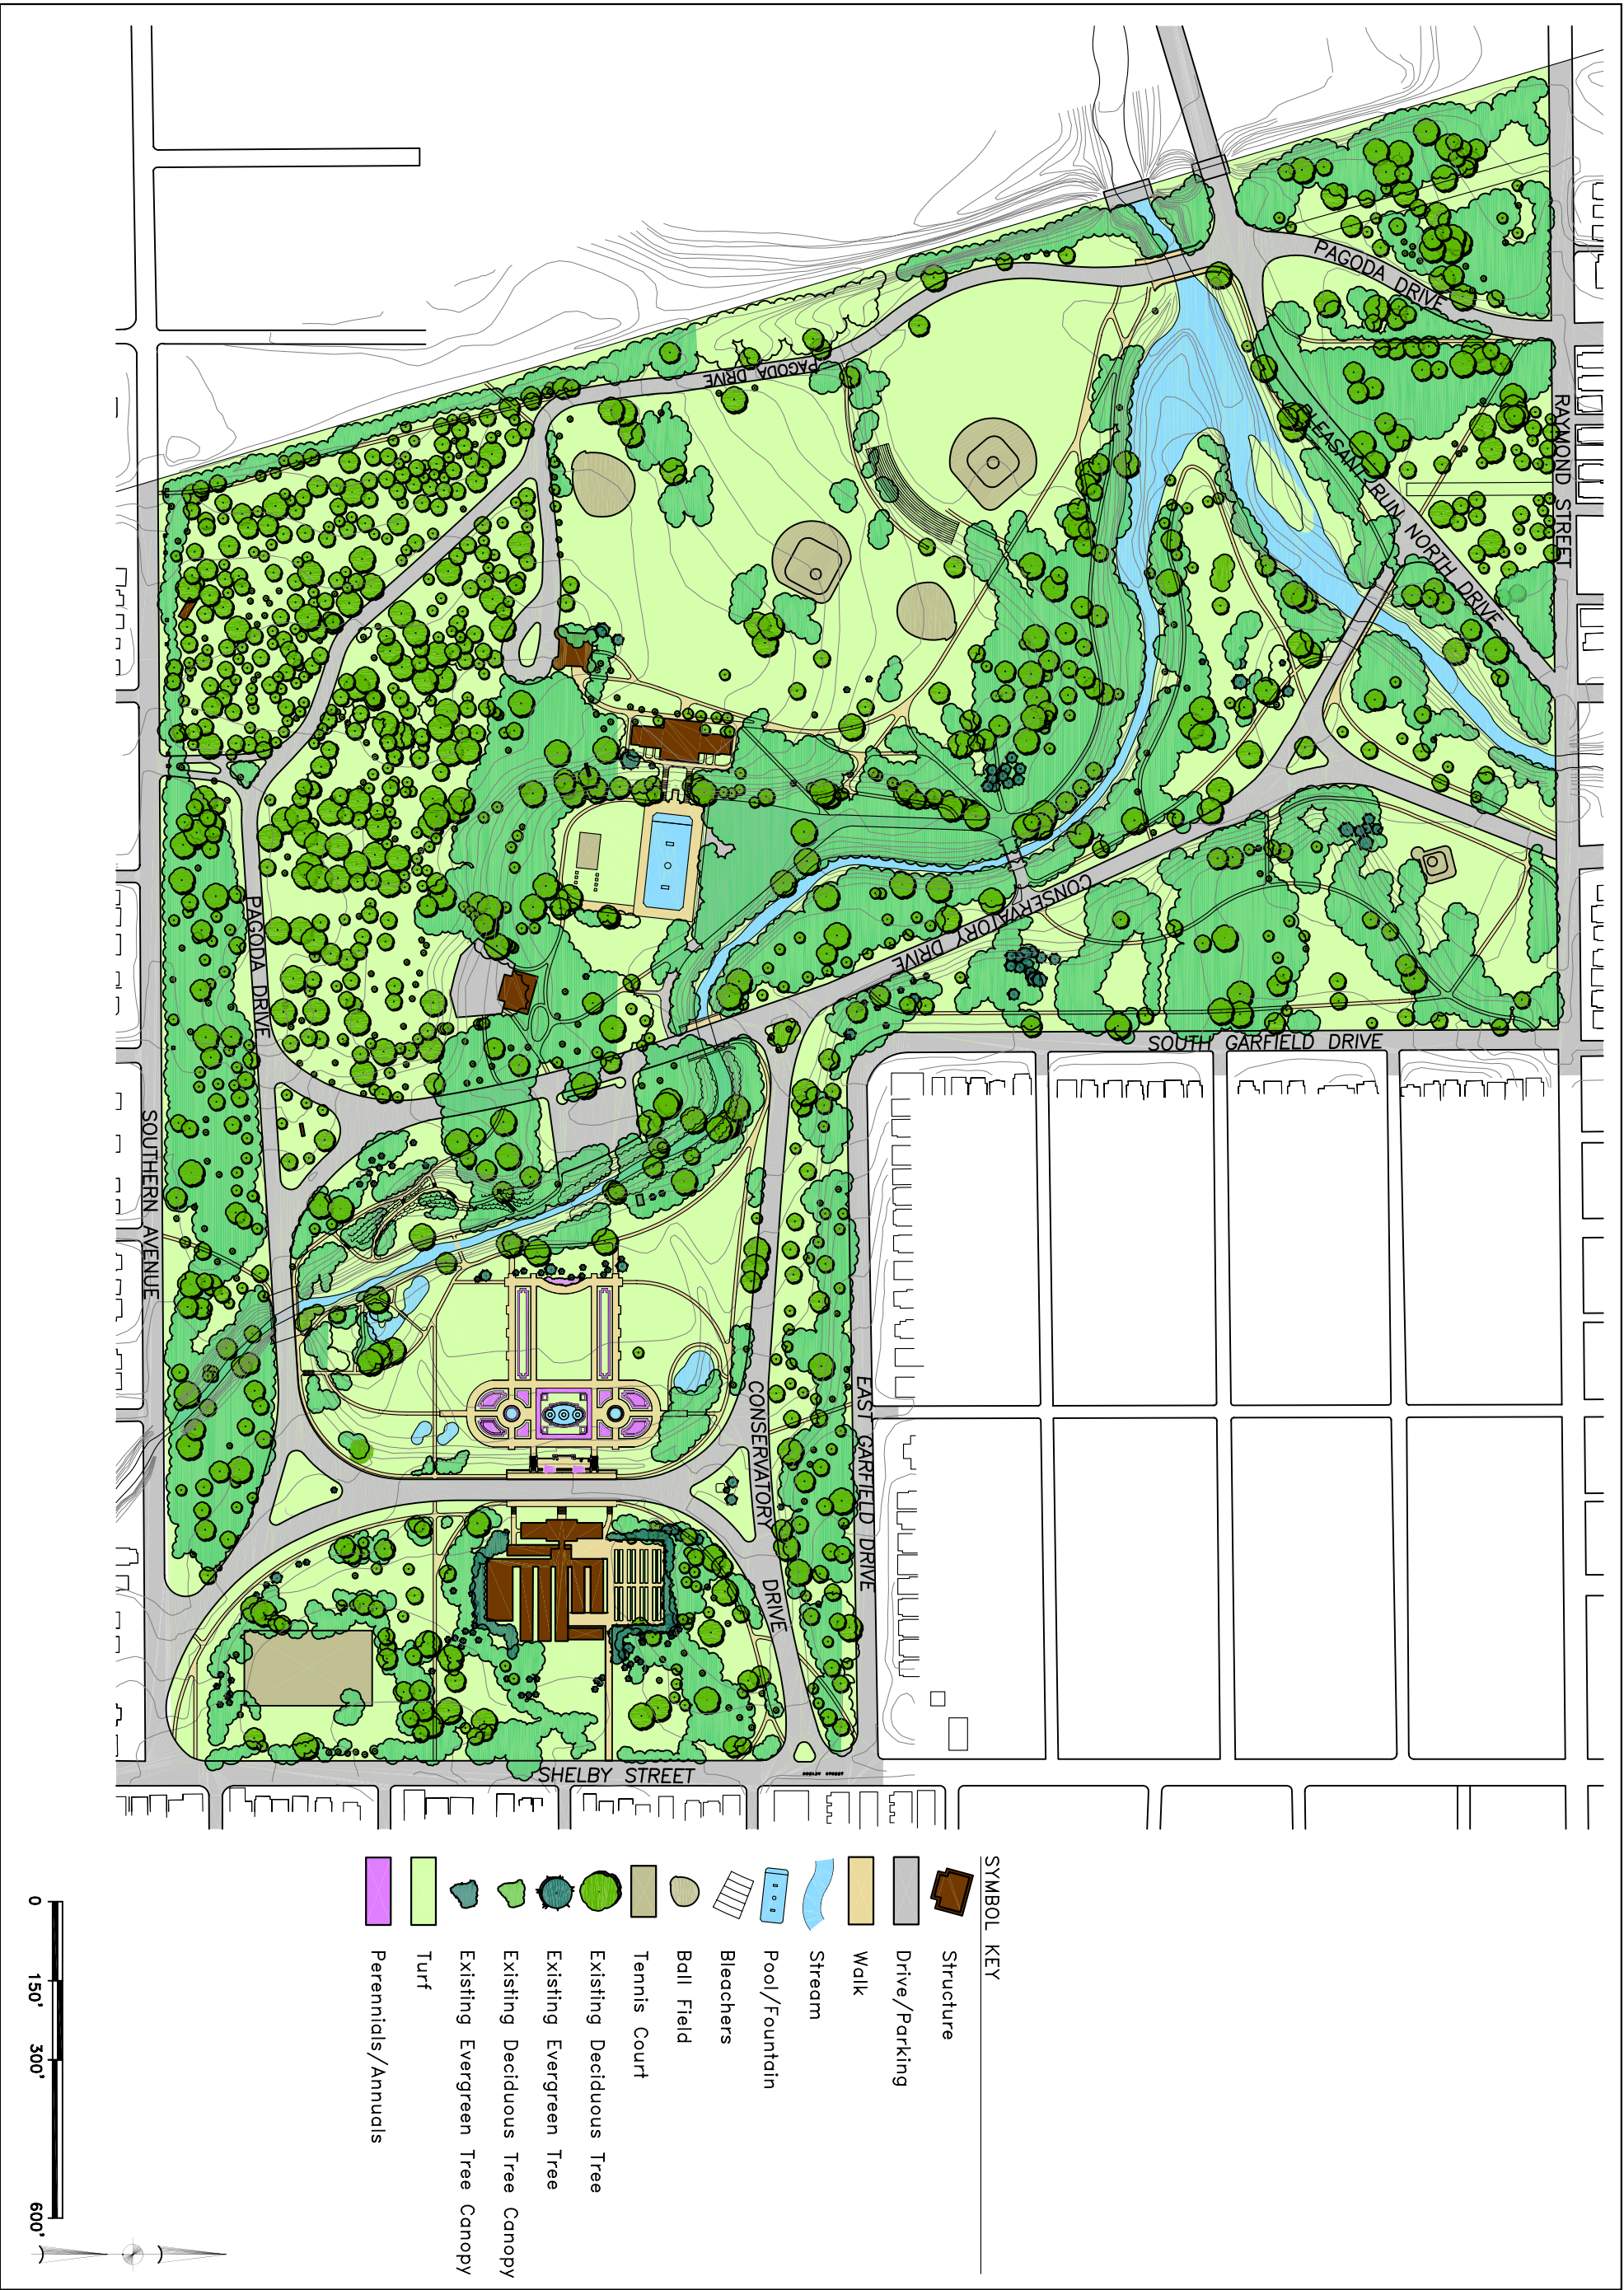
KP1913

Indianapolis Indiana
1913 Kessler Plan

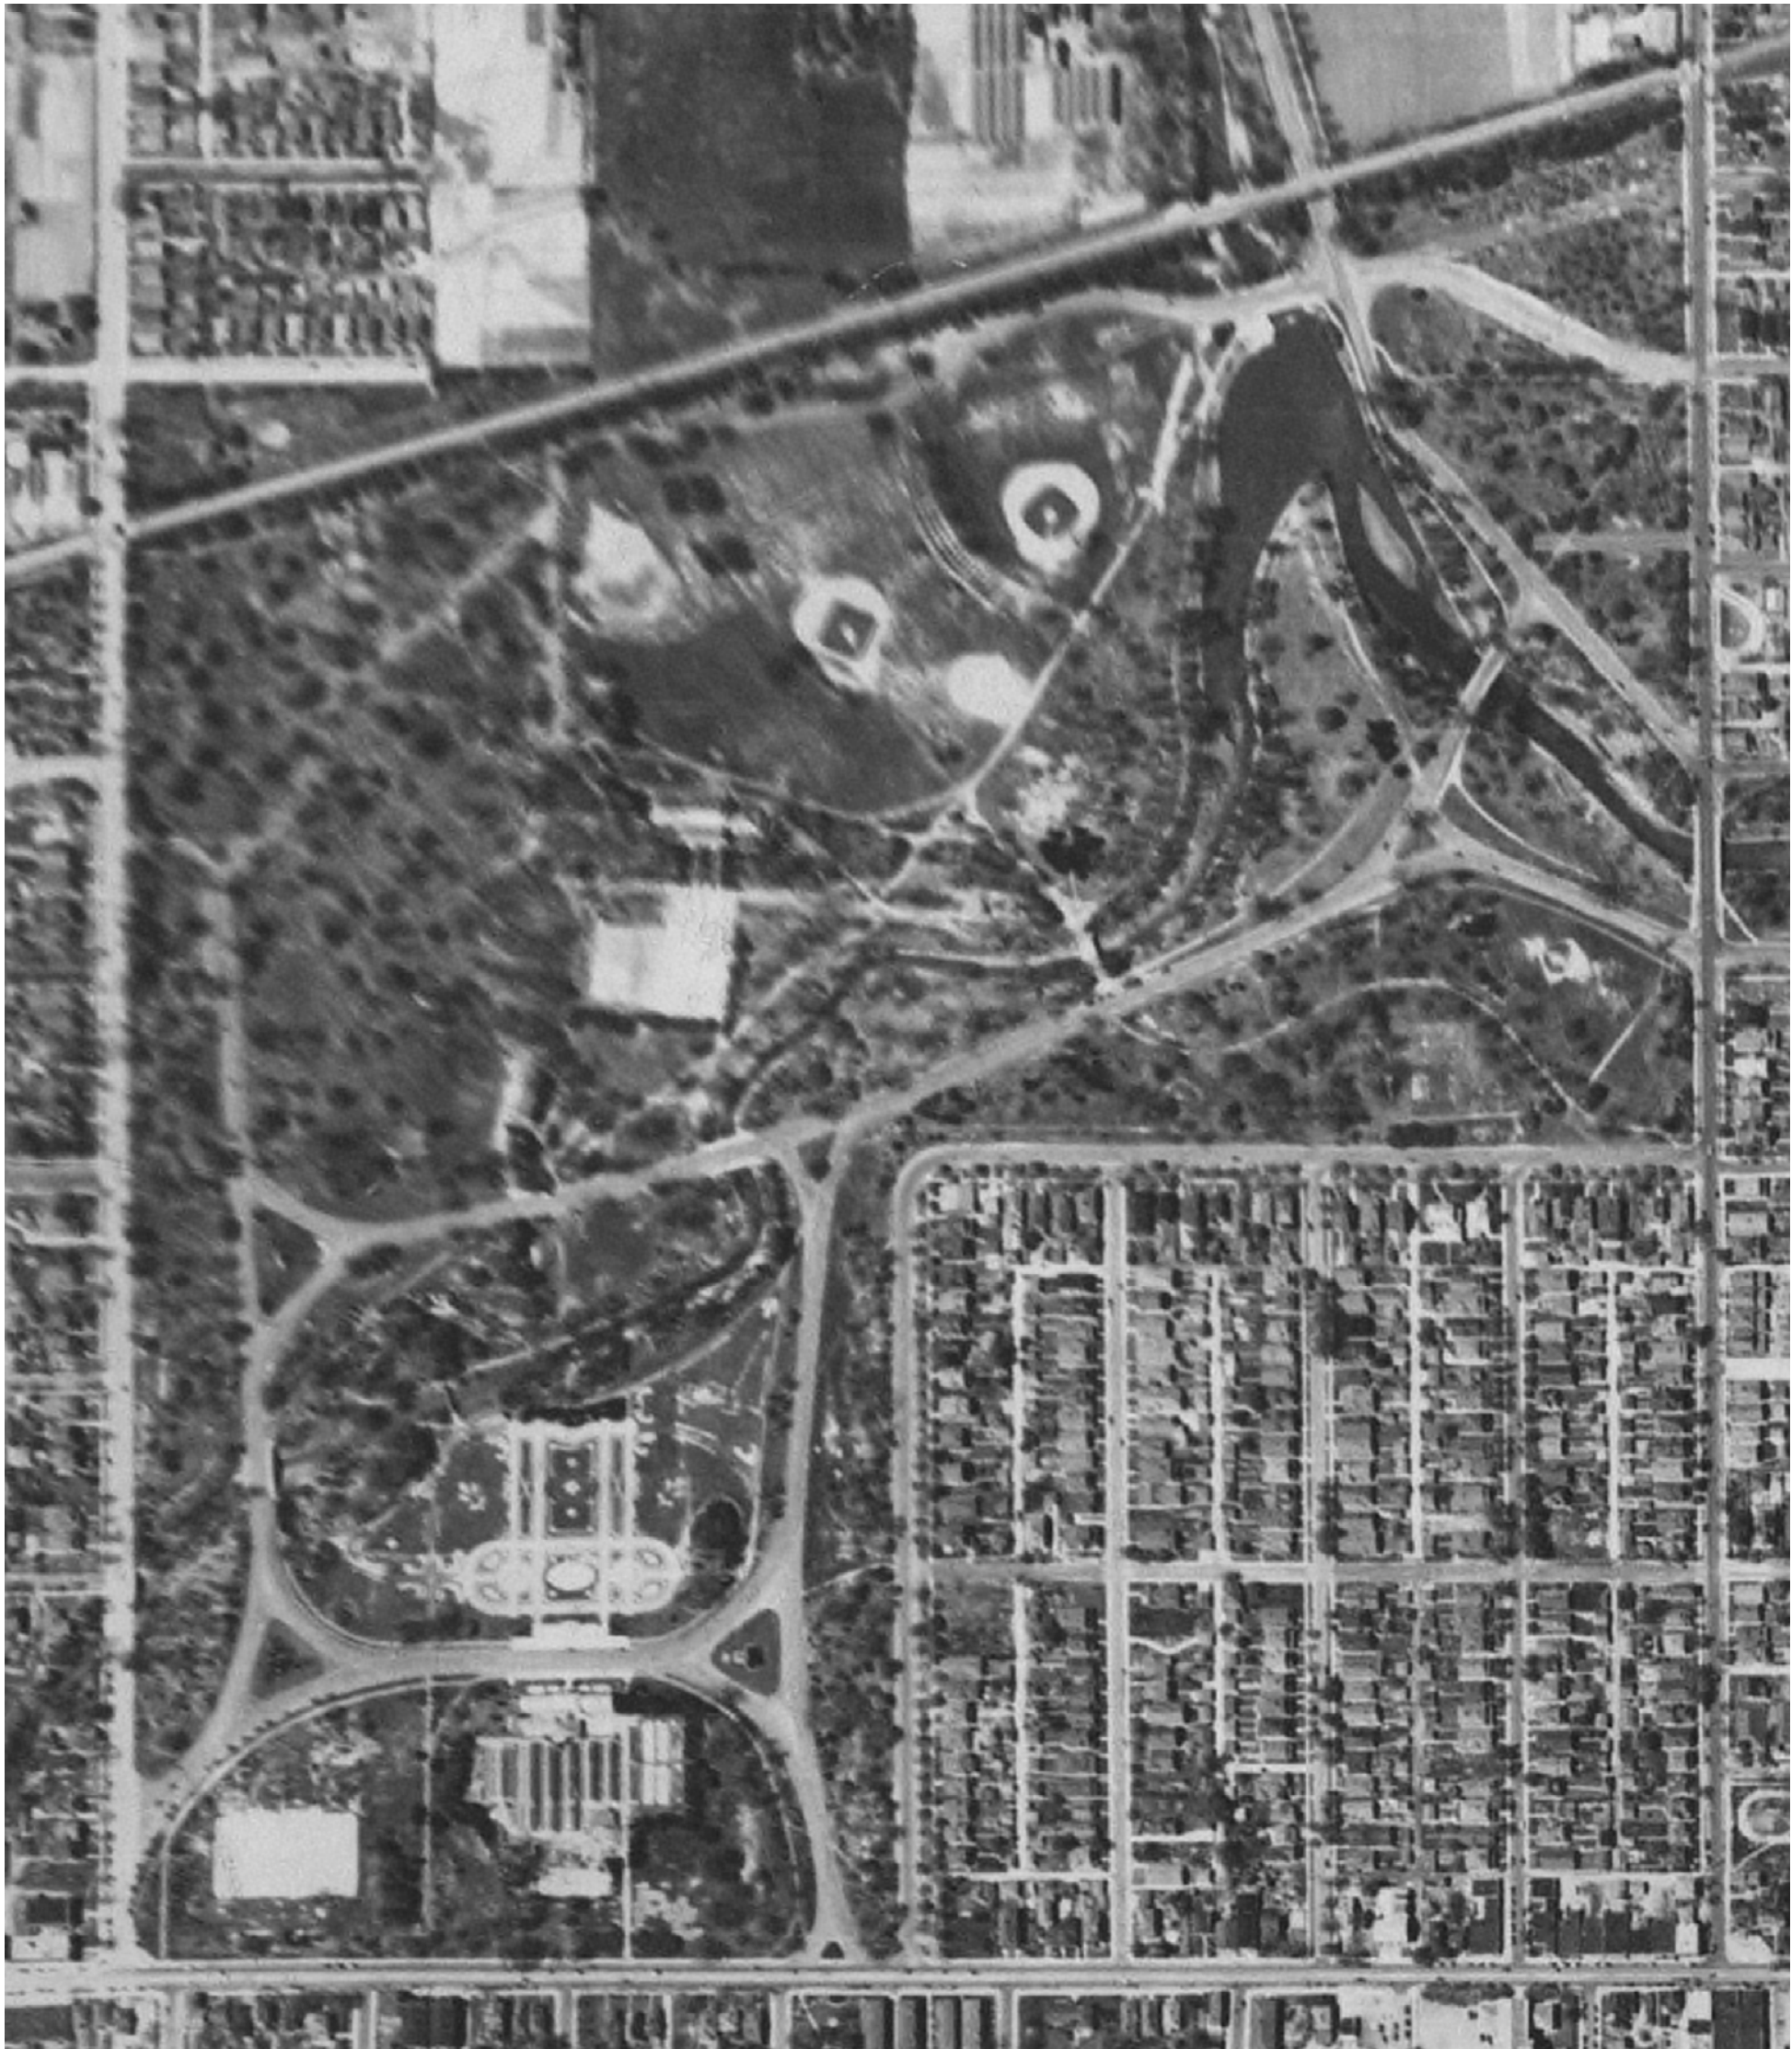
AP1937

There are ample archival materials, historic images, and aerial photographs taken in 1937 and 1941 that provide sound documentation of the park and are utilized in this chapter to provide a detailed description of the Garfield Park landscape during the 1930s. Heritage Landscapes has prepared several plans to accompany the text and images in this chapter. The Period Plan for the 1930s (PP1930s) shows the natural and as-built documented conditions of the park at this time. Natural elements, such as the topography, that exist today are accepted as being present during the 1930s unless clear period documentation of another condition, such as the lake, is known. All available sources were consulted with emphasis on documentation from city mapping, property and insurance surveys, and aerial and ground photography. The 1937 Aerial Photograph (AP1937) is shown at the same scale and orientation as the Period Plan. The 1941 Aerial Photograph (AP1941) provides additional clarity on the vegetative cover of the parkland.

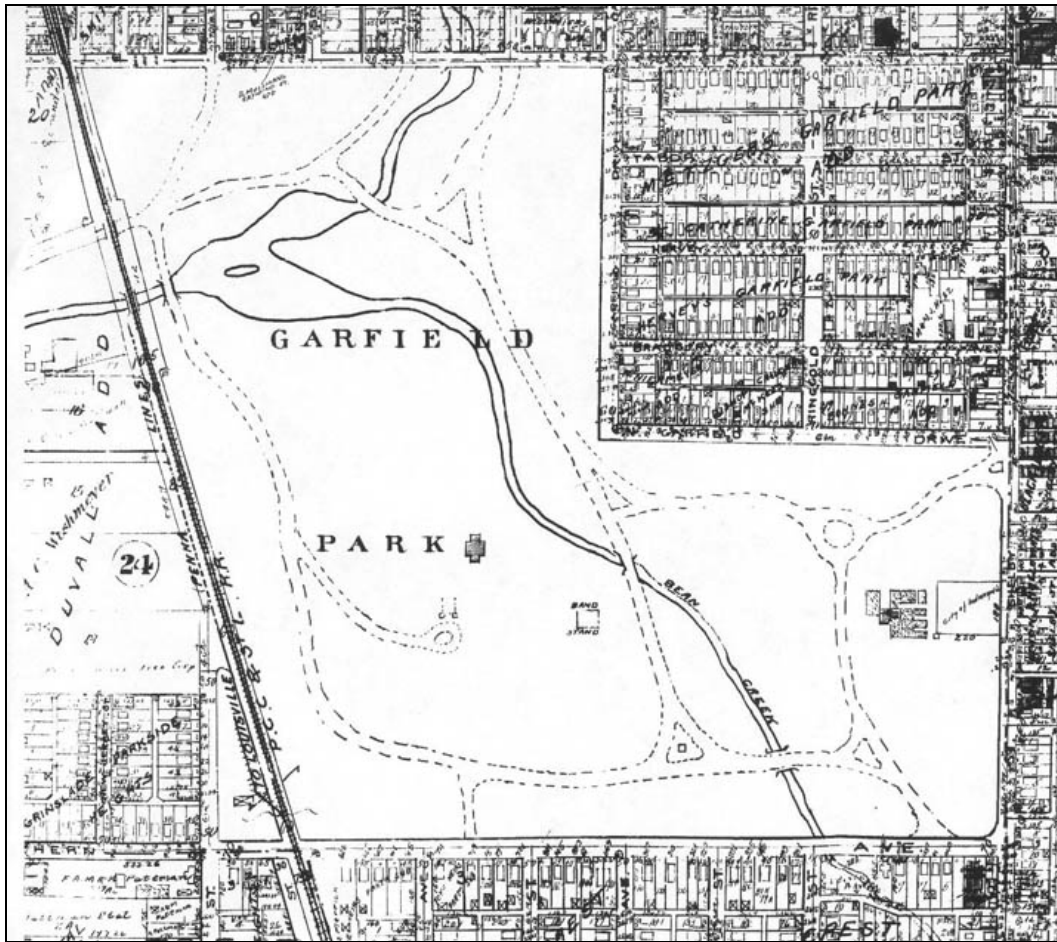
Figure III.1 Baist Map of Indianapolis, 1941, showing park drives, streams, structures, and surrounding neighborhood with small residential lots. (R-Baist1941.jpg)

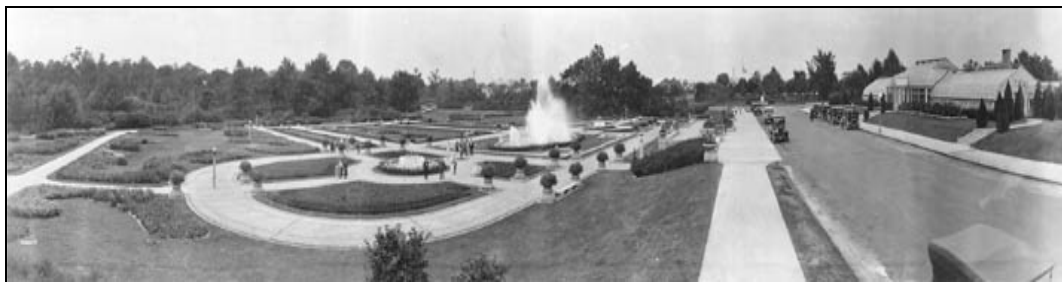
Figure III.2 Panoramic view of the Conservatory and Sunken Gardens in 1923 clearly showing the three levels and symmetrical arrangement of steps, walks, beds, turf, and fountains. (R-PO130_56061-F ISL)

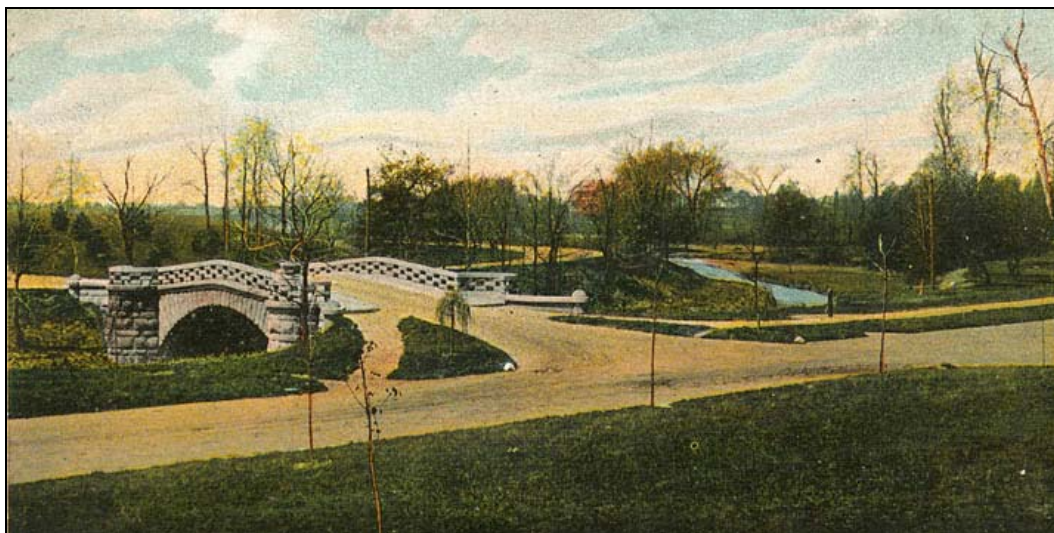
Figure III.10 Postcard view circa 1906 of park gravel drives, turf, young trees, and the distinctive bridge with block-and-void style railings on Bean Creek. (R-PO391_000_0100_Bridge_1906.jpg IHS)

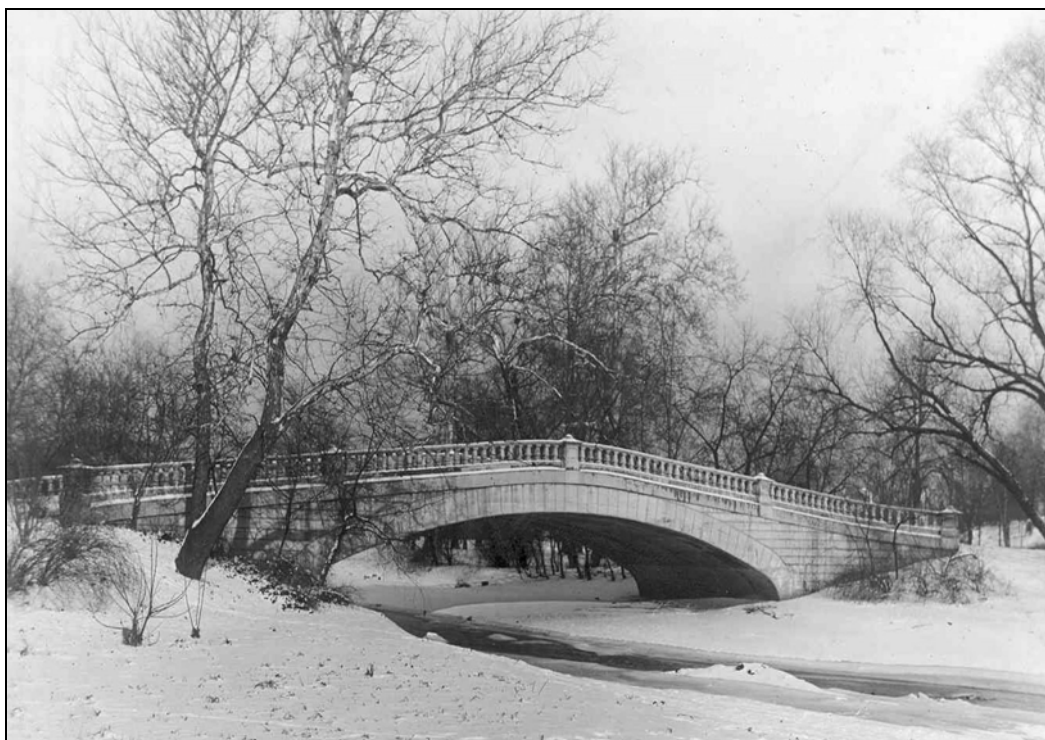
Figure III.11 Winter view of arc-en-panier style of the Pleasant Run bridge and wooded banks circa 1910. (R-7_bridge.jpg IHPC)

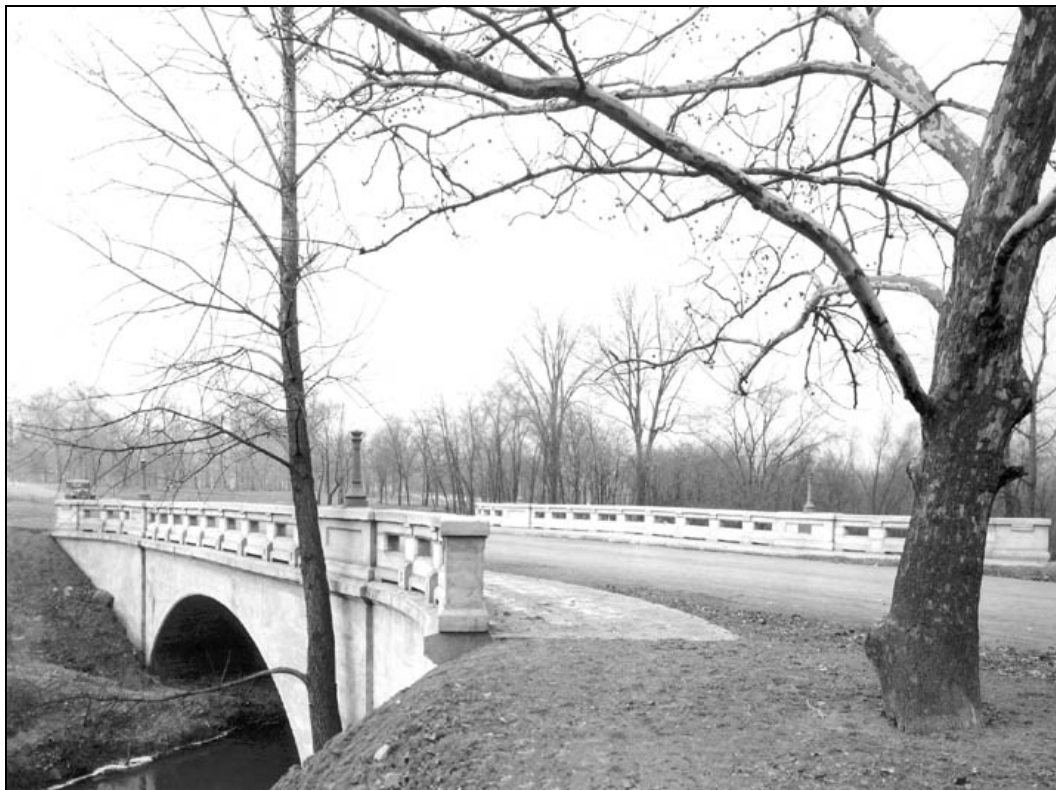
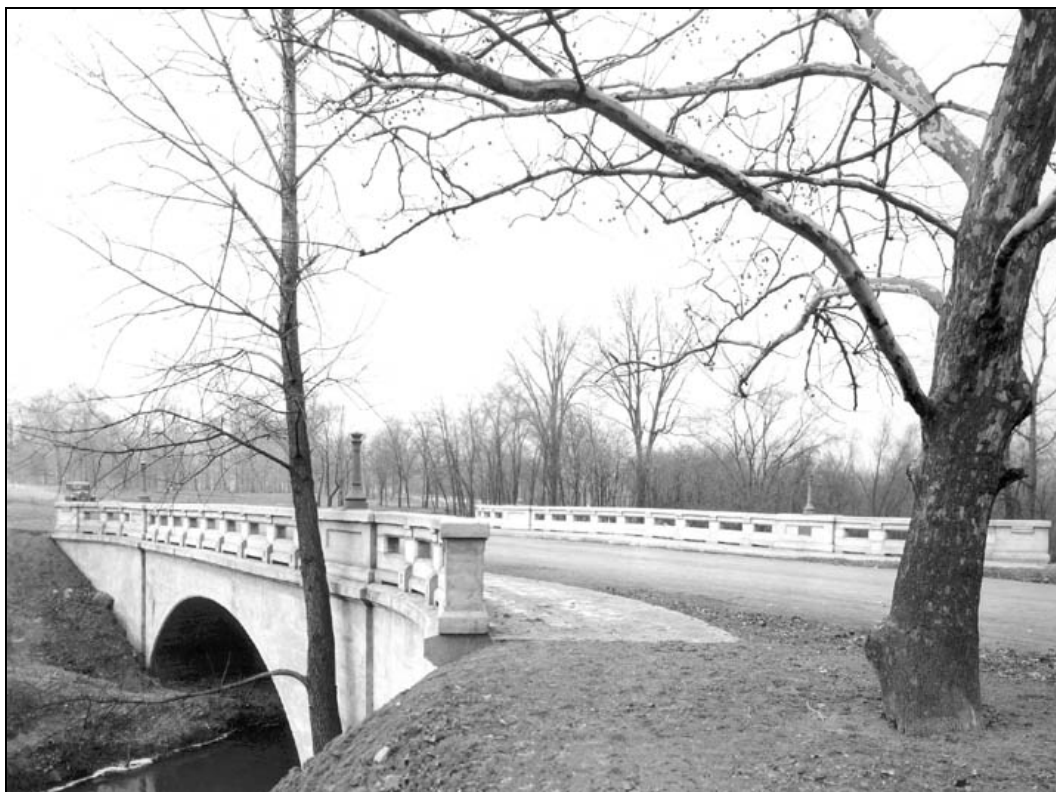
Figure III.12 View of the reinforced concrete Pagoda Drive bridge built in 1923, with open turf slopes and two trees; the larger one is a native sycamore. (R-8_sbridge.jpg IHPC)
