GARFIELD PARK CULTURAL LANDSCAPE REPORT

Chapter III: 1930s As-Built Character

A. INTRODUCTION

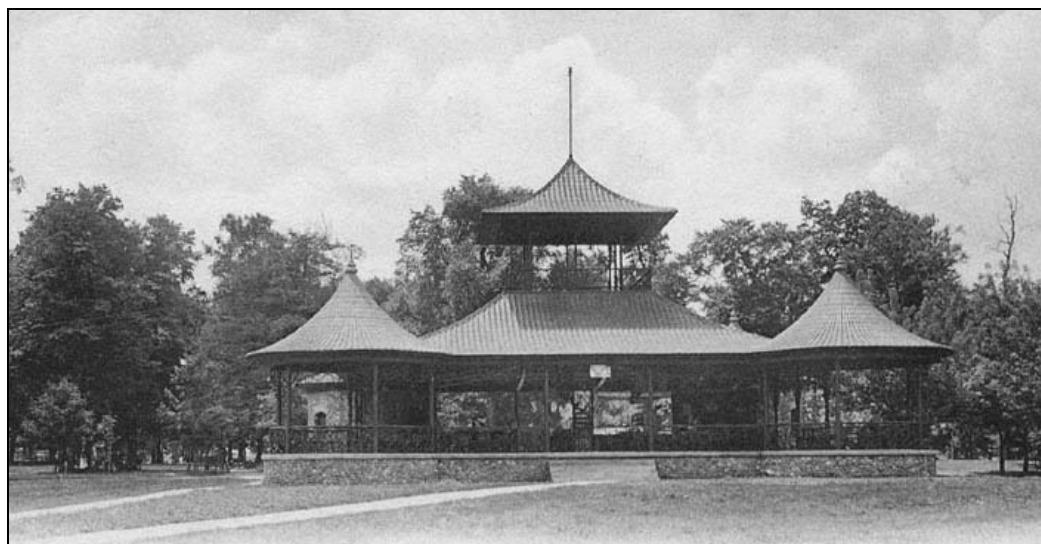
Figure III.13 View of oriental style Pagoda built in 1903 showing cobblestone structure, multiple curved roofs, iron railing, open turf, and background trees. (R-PO391_A27004_pagoda.jpg IHS)

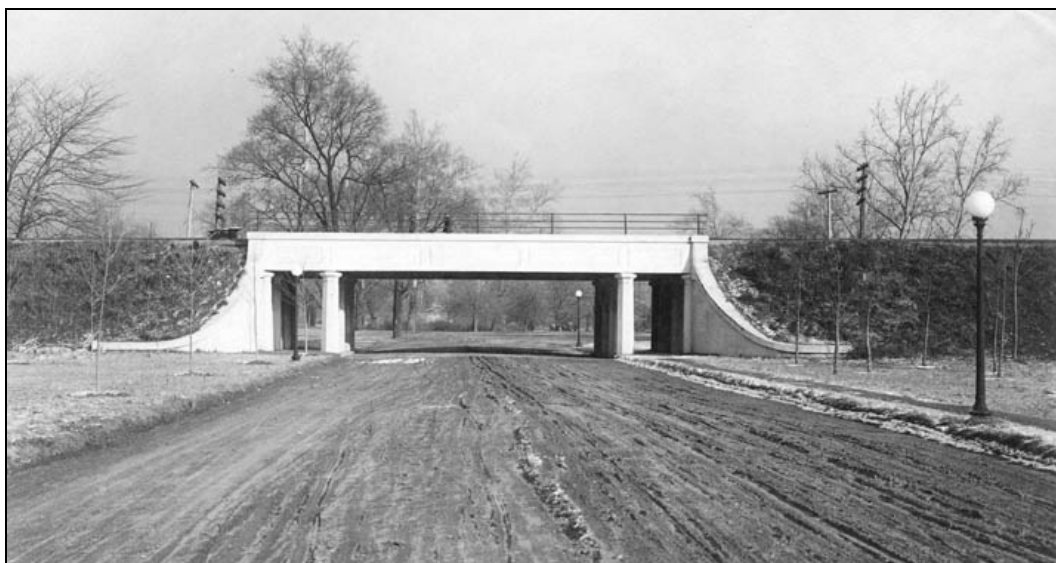
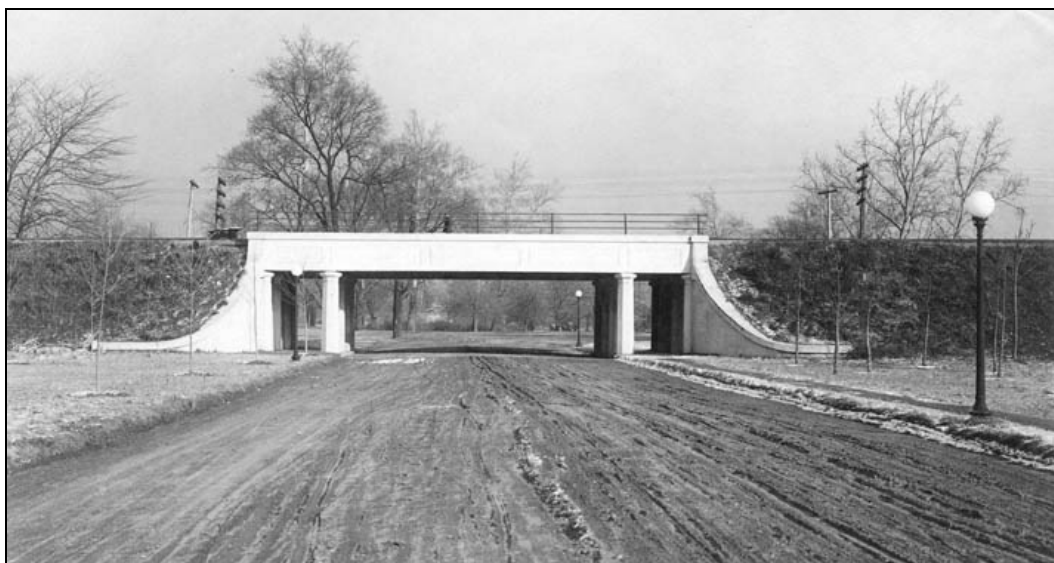
Figure III.14 The subway provided vehicular and pedestrian access through the railroad embankment. (R-LP0008_13260_subway.jpg IHS)
