## GARFIELD PARK CULTURAL LANDSCAPE REPORT

### Chapter V: Landscape Change 1930s to 2004

## Cultural Landscape Report

### Indianapolis, Indiana

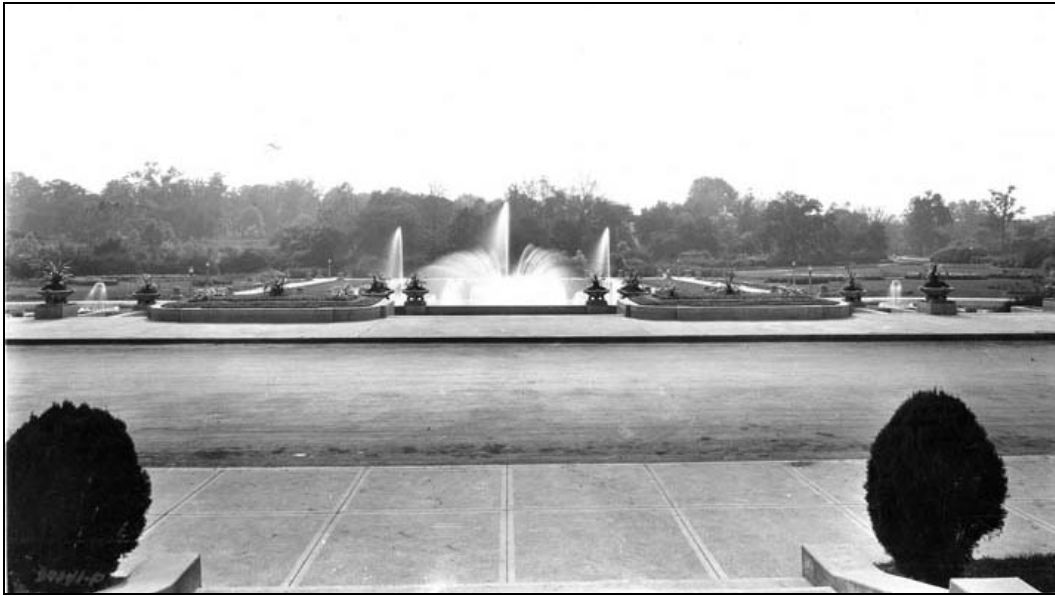
**Figure V.1** A 1924 view from the Conservatory entrance west over the drive, Overlook, and Sunken Gardens with the fountains. The spatial relationships of these elements along the axis are apparent. (R-PO130\_87105-F.jpg IHS)

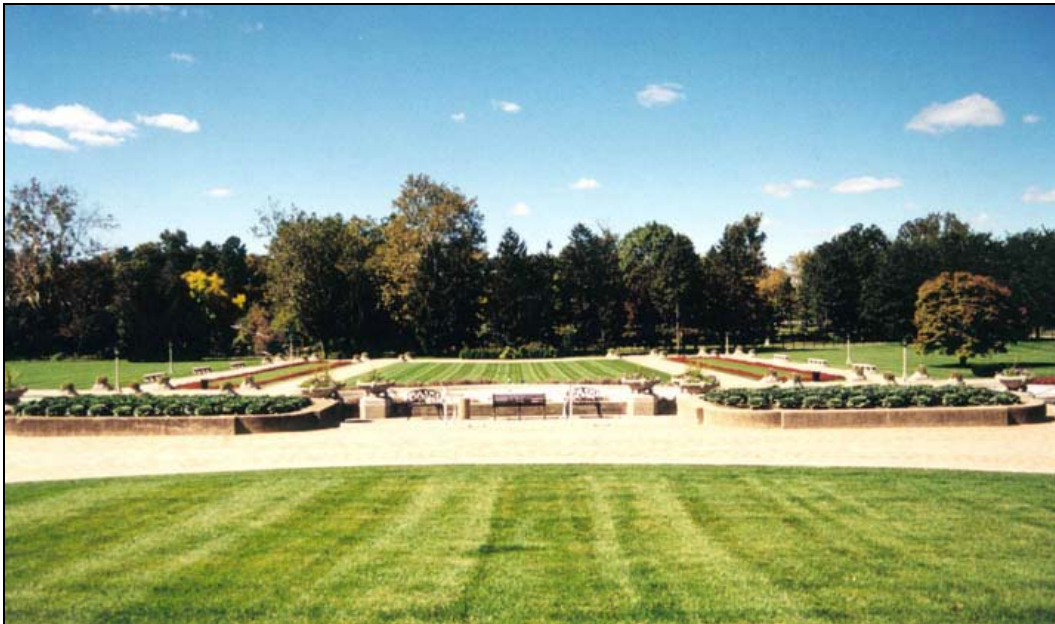
**Figure V.2** A pedestrian terrace overlooking the Sunken Gardens replaces the Overlook drive today. The steps and axial, symmetrical gardens are similar to the 1924 view. (R-V-2-HL.jpg)

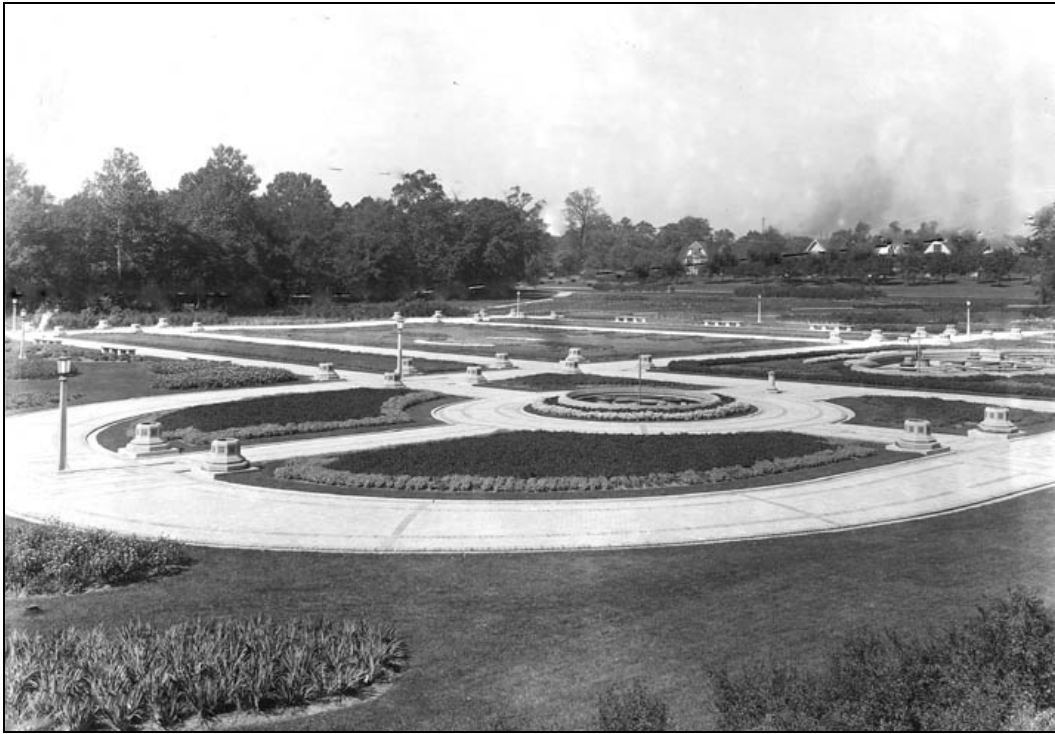
**Figure V.3** The 1917 Gardens with formal design, planting, and custom-designed furnishings. The open north boundary with houses is visible. (R-PO130\_61798-F.jpg IHS)

The form and planting of the central panels of the Gardens, seen in Figures V.3 and V.4, and in the 2002 aerial photograph at the end of Chapter IV, are also similar to the patterns of the 1920s and 1930s, though the central planting beds have been reduced from those seen in the 1937 aerial photograph at the end of Chapter III, and the angled drifts of perennials on the sides are not used now. The density of the trees at the west end of the gardens appears similar, while the view to the houses on the north seems more open in the older photograph. The trees surrounding the Gardens have matured and a new generation been planted that is now in many cases at a similar stage of growth albeit of different species. Figures V.5 and V.6 show the terminating bed of the west axis with an almost identical planting of cannas. In these images the older photograph shows deciduous trees as the backdrop while the recent image has mature spruce. On the south side of the Conservatory an allée of young maples has recently been added to the south entrance walk, which replaces the original drive (seen in Chapter IV, Fig.IV.9). To the north of the Conservatory, along East Garfield Drive, and in the area of the tennis courts south of the Conservatory fully mature trees are interspersed with recent plantings. The main entrance to the Conservatory is now at the north end of the building, emphasized with a more formal planting of hornbeam, yew, and flowering trees.

The 1930s furnishings in the Sunken Gardens, such as the urns, planters, lampposts, and benches have been replicated, as seen in Figures V.3 and V.4. The walkways have been re-built using the original pattern but in modern, low-maintenance, concrete brick-style pavers that are a noticeable change in material. The benches on the Overlook are now a mixture of styles and periods. A noticeable change is the black metal fencing surrounding the Sunken Gardens, and the high, ornamented, metal gates for the Terrace and Overlook. The fence allows good visibility of the Gardens and is in keeping with their period look. The ornamented gates, seen in Chapter IV in Figure IV.2, are out of context with the surroundings, and are a visual distraction from the historic design relationship of the Conservatory to the Overlook and on to the Sunken Gardens.

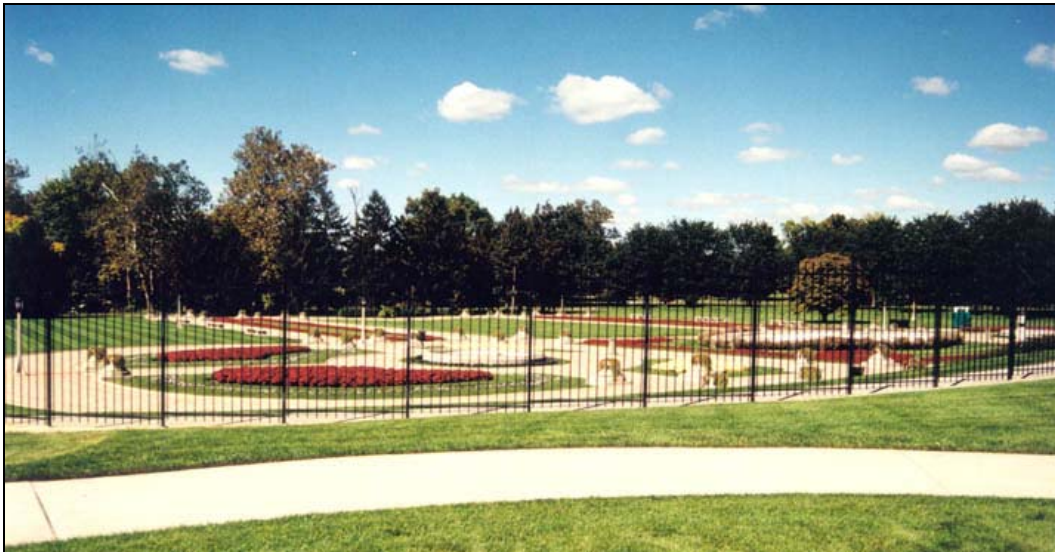
**Figure V.4** From outside the Gardens, the new perimeter fence encloses the paths, plantings, and furnishings replicating the historic elements. There are more trees to the north and a single flowering cherry on the right. (R-V-4-HL.jpg)

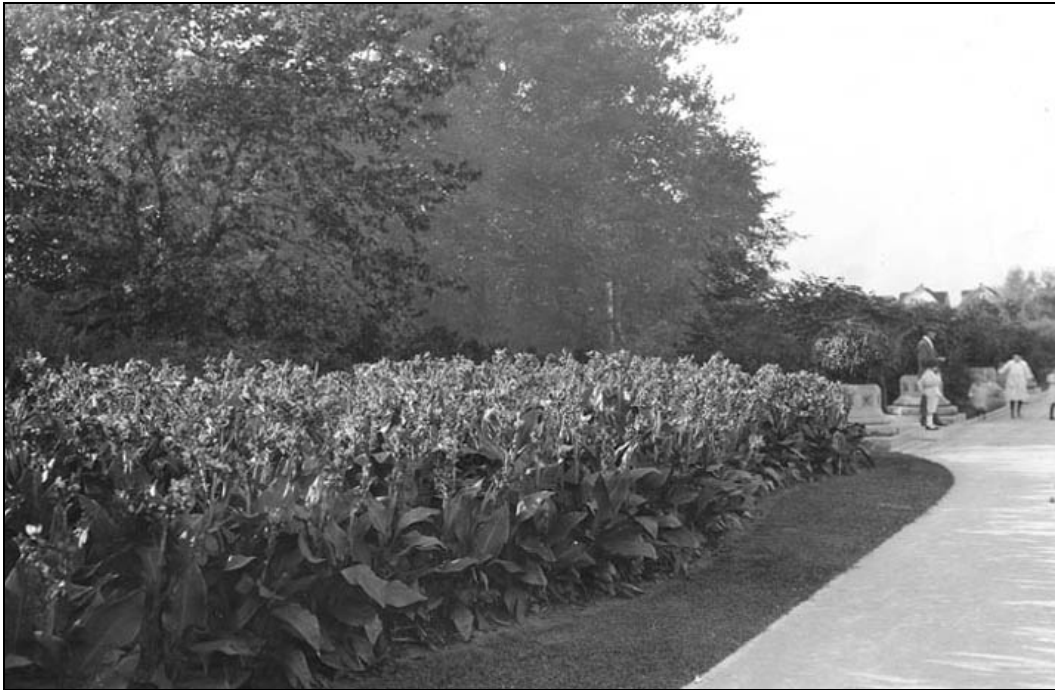
**Figure V.5** The 1920 floral bed at the west end of the Gardens. The strong forms of exotic tropical plants create a focal point and terminate the axis. (R-PO130\_71761-F.jpg IHS)

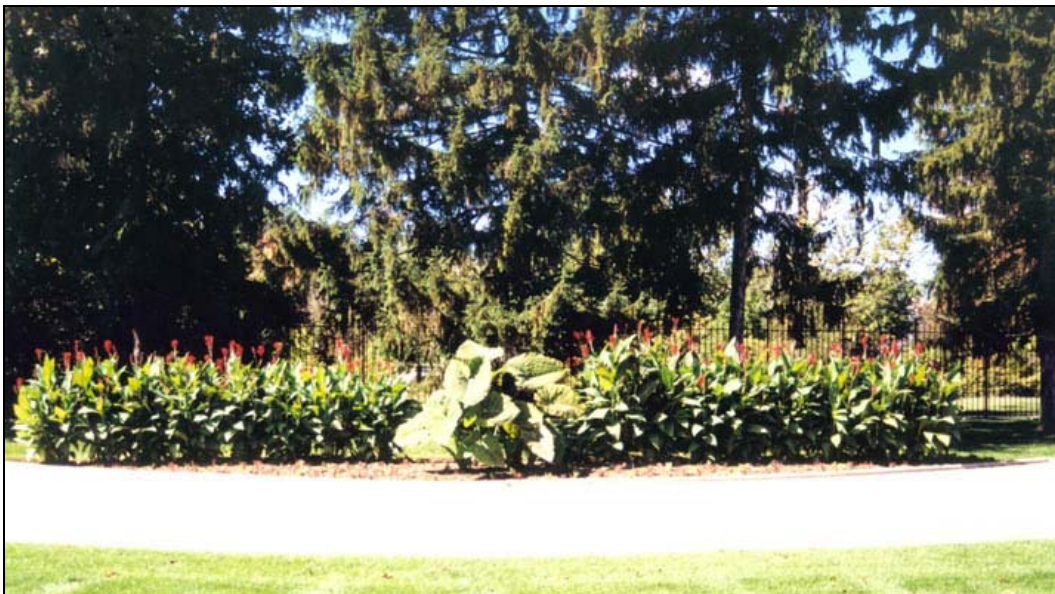
**Figure V.6** In 2003, framing a central taro plant, the cannas are still used to achieve a bold texture and effect that matches the historic look. A spruce screen, rather than deciduous trees, forms the background. (R-V-6-HL.jpg)

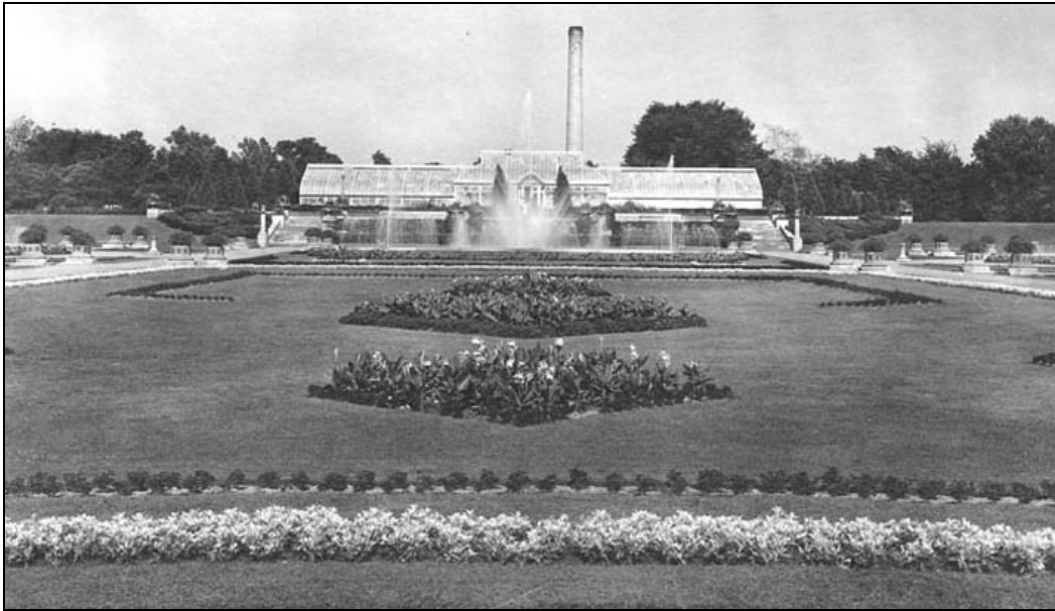
**Figure V.7** A 1937 view east across the Gardens to the Overlook and original Conservatory. There were plantings in the central panel at that period. (R-PO130\_238280F-C.jpg IHS)

The original Conservatory with its arched entrance and curved lines, seen in Figure V.7, was replaced in 1954 by a more rectilinear design featuring the Art Deco limestone façade. Repairs to the Conservatory have retained this 1954 design and added the accessible entrance and shop on the north end (Figure V.8). All but one of the greenhouses behind the Conservatory have been removed and a storage building with fencing has been added. The Shelby Branch Library and adjoining parking lot were added, with pines planted to screen the working area of the

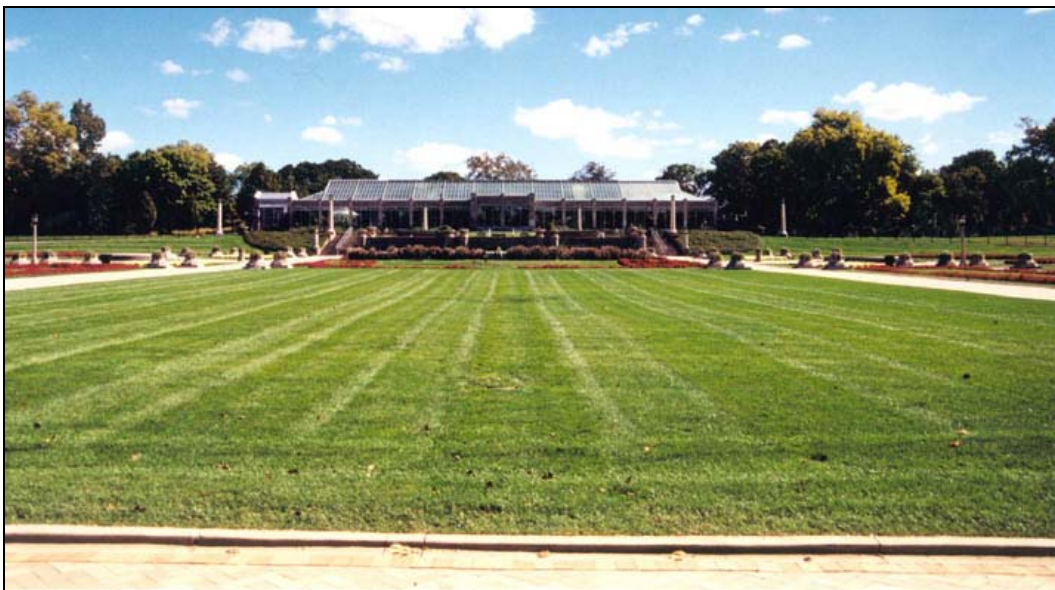
**Figure V.8** A 2003 view across the Gardens to the present Conservatory with its 1954 Art Deco façade and the contemporary north extension. The center panel is not planted as it was historically. (R-V-8-HL.jpg)

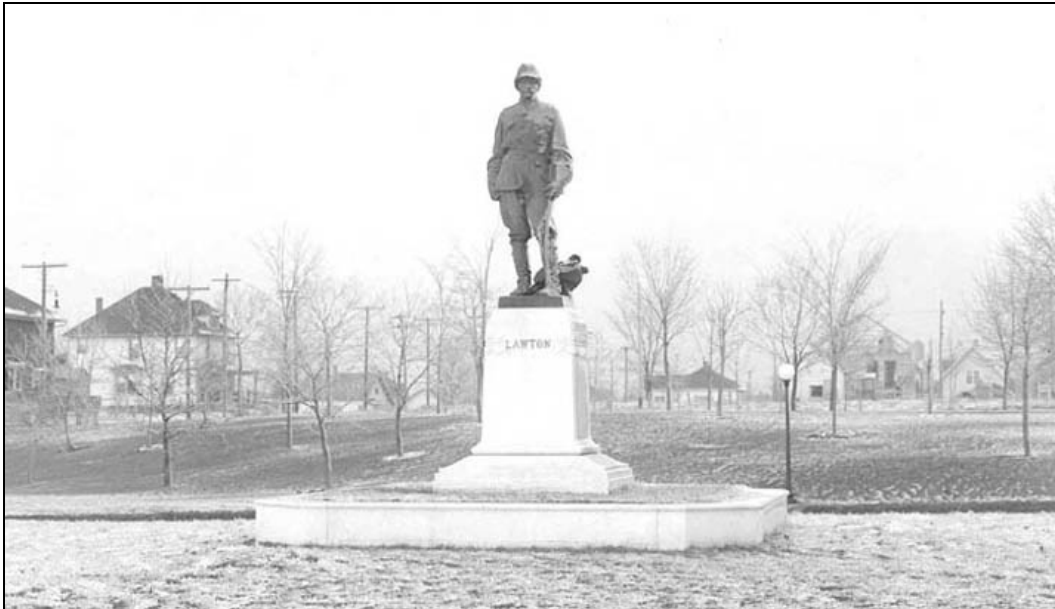
**Figure V.9** The statue of General Lawton at the time of dedication in 1915. The neighborhood is sparsely built, with new trees planted in the buffer area. No planting has been done around the statue. (R-11.jpg IHPC)

Figures V.9 and V.10 show the changed surroundings of the statue of General Lawton in the north entry triangle from the conditions after its installation in 1915 to the present. Figure V.9 shows the open ground of 1915. Figure III.6 in Chapter III shows the growth of background plantings of shrubbery and young trees around the statue by the late 1920s. Figure V.10 shows the statue in 2003 framed by mature spruce trees with their lower limbs removed. The spatial quality is almost similar to the earliest photograph again.

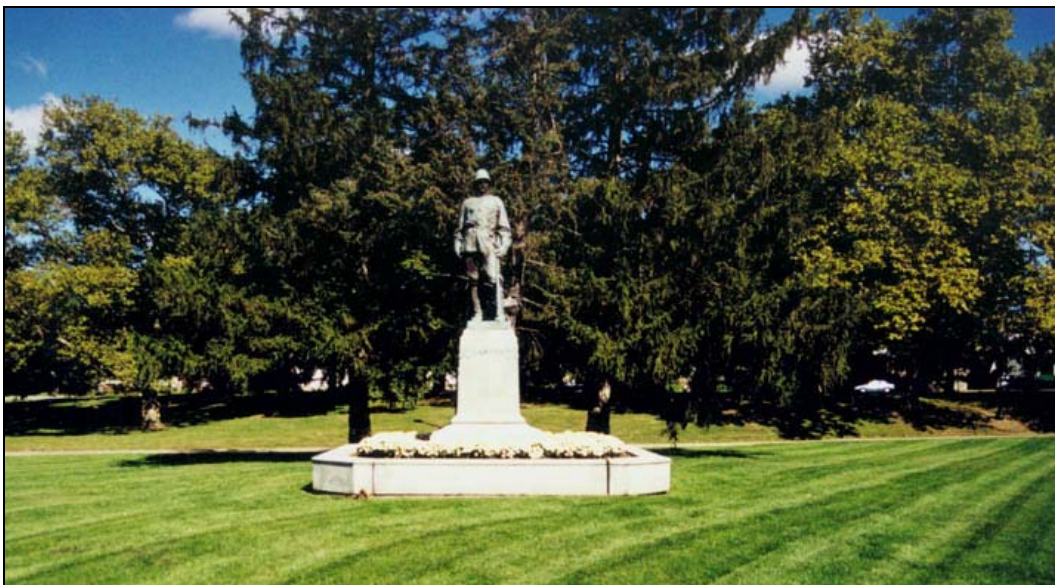
**Figure V.10** In 2003 the statue of General Lawton is backed by mature spruce with the mature buffer of trees beyond. Annuals are planted on the base of the monument. (R-V-10-HL.jpg)

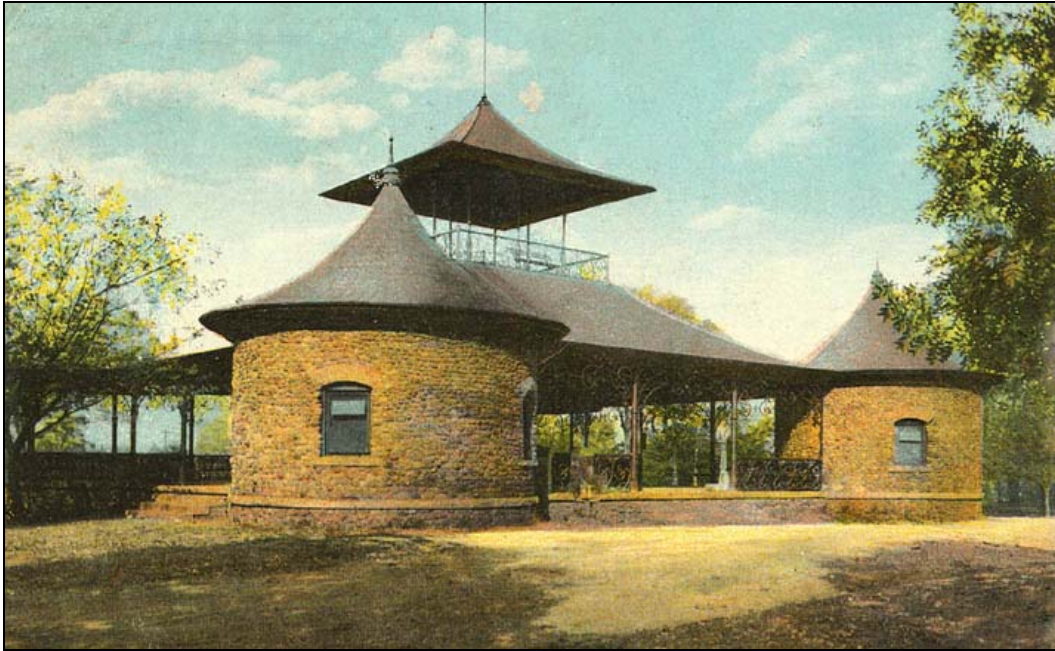
**Figure V.11** An early image of the Pagoda on an undated postcard, circa 1910s. Though renovated twice, the structure has the same materials and details today. (R-O391\_000\_0100\_D6242.jpg IHS)

As seen in the comparative photographs of Figures V.11 and V.12, the Pagoda remains the same although the surrounding area has changed with the addition of the playground, a double parking lot on Pagoda Drive with a wide delivery/ walk access, and picnic shelters. Generally these are sited in a manner that does not interfere with the iconic status of the Pagoda. The now-mature pines next to the Pagoda, seen in Figure IV.20, enhance the “oriental” style of the structure.

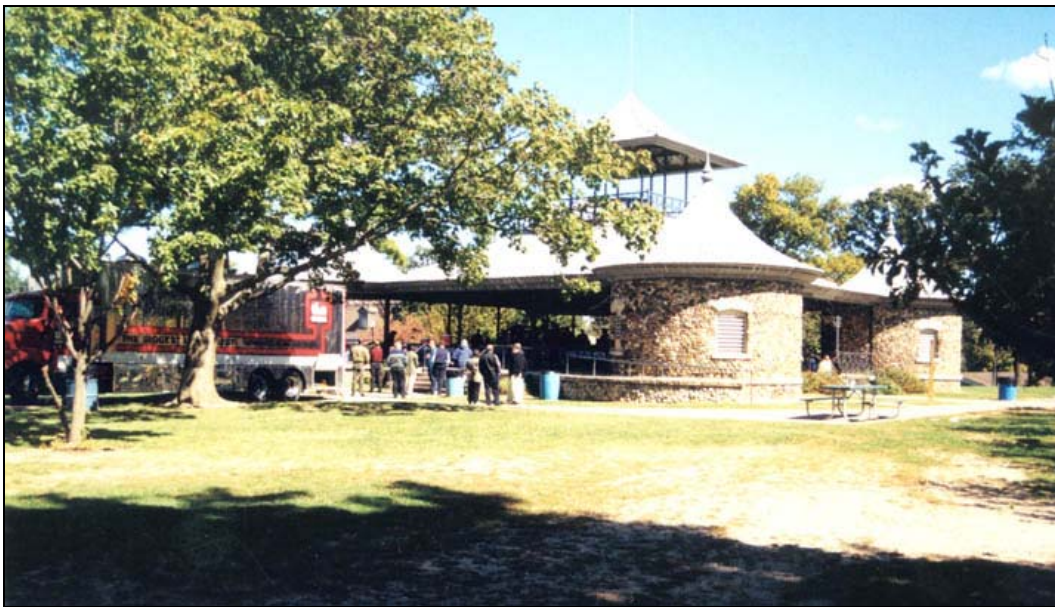
**Figure V.12** The Pagoda in 2003. Louvered shutters have been added and the access walk is evident from the position of the delivery truck. The trashcans and picnic table are contemporary additions. On the opposite side of the structure, a highly developed garden and playground were recently added. (R-V-12-HL.jpg)

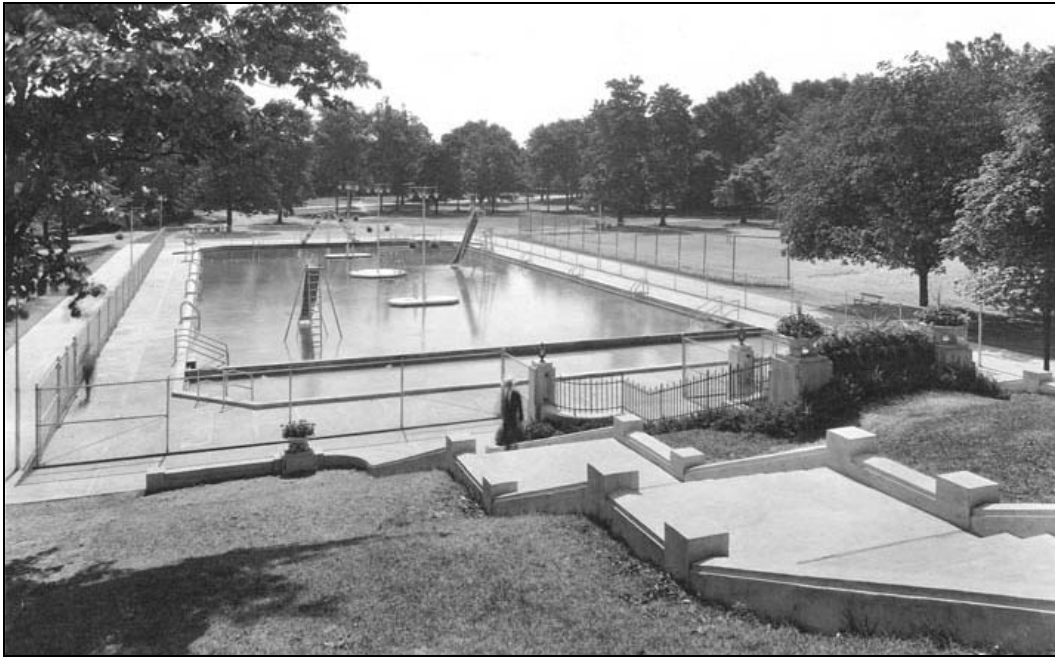
**Figure V.13** The new Olympic-sized swimming pool in 1930 surrounded by maturing trees. (R-PO130\_216948-F.jpg IHS)

The 1930s swimming pool, seen in Figure V.13, has been filled in and surfaced as a parking lot for the renovated MacAllister Center for the Performing Arts amphitheater (Figure V.14). The MacAllister Center stage is housed in a brick building open on the stage side and facing increased amount of permanent seating on the sloped lawn.

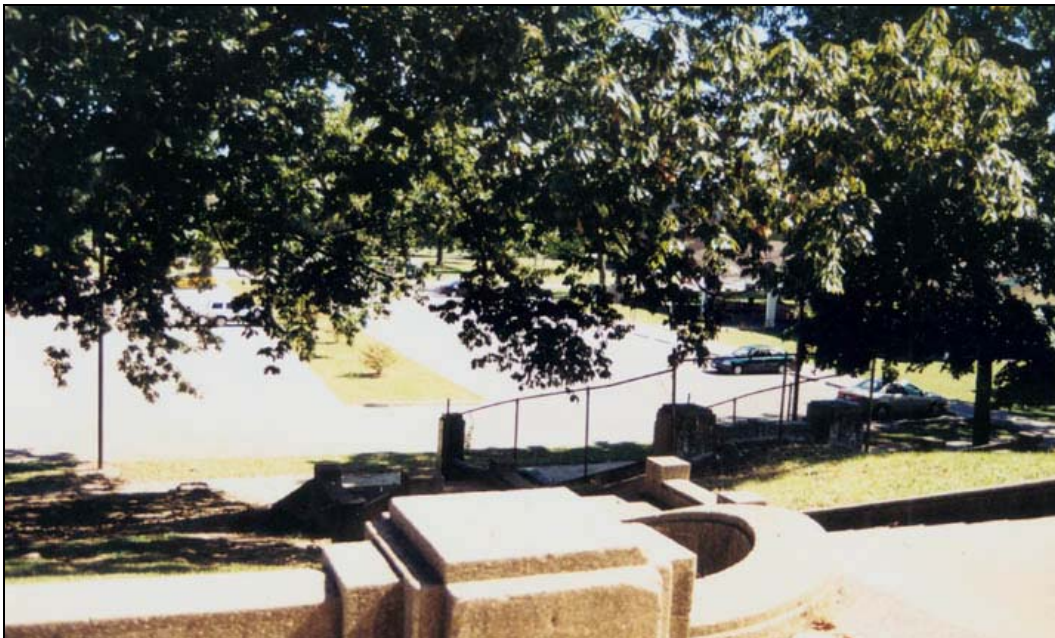
**Figure V.14** The same view in 2003. The space is now a parking lot for the MacAllister Performing Arts Center and the Garfield Arts Center. (R-V-14-HL.jpg)

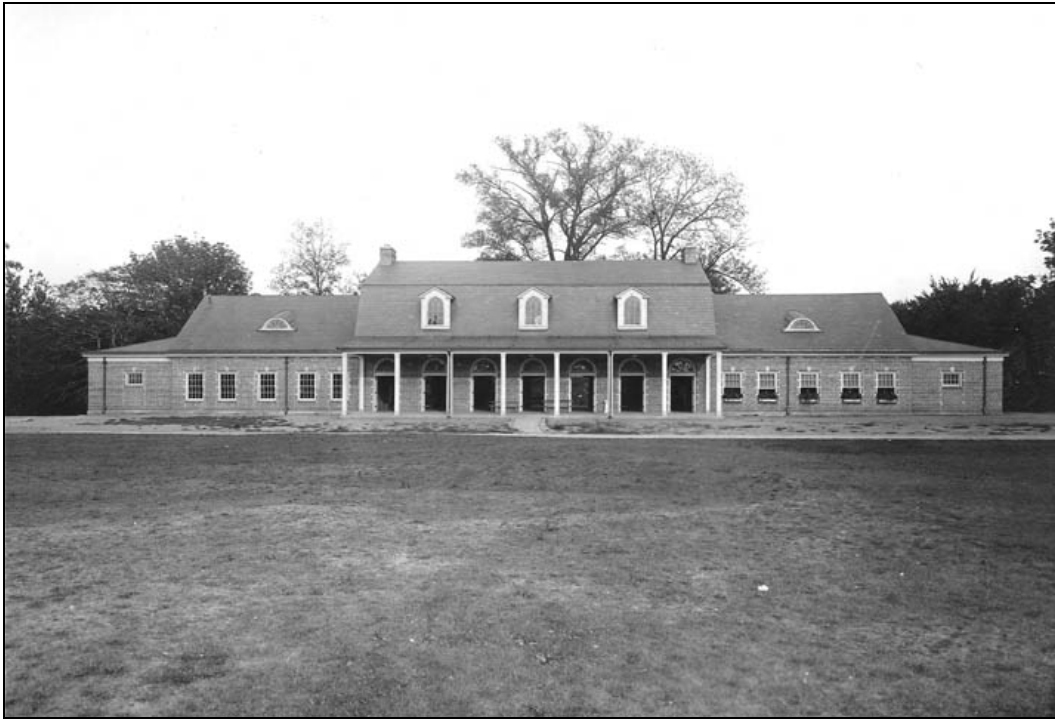
**Figure V.15** The Outdoor Shelter, or Community House, as it was known at the time of this photograph in 1922. (R-PO130\_79673-F.jpg IHS)

The Community Shelter/ Arts Center, presented as it looked when it opened in 1922 (Figure V.15), remains the same externally (Figure V.16). The low shrubs in front, shown in the older photograph, have been replaced by a planting of flowering crabapples. The building still anchors the expanse of the playing fields as it did in the 1930s (Figures V.17 and V.18). The interior is due to be renovated to accommodate instruction and exhibition facilities for all the art forms.

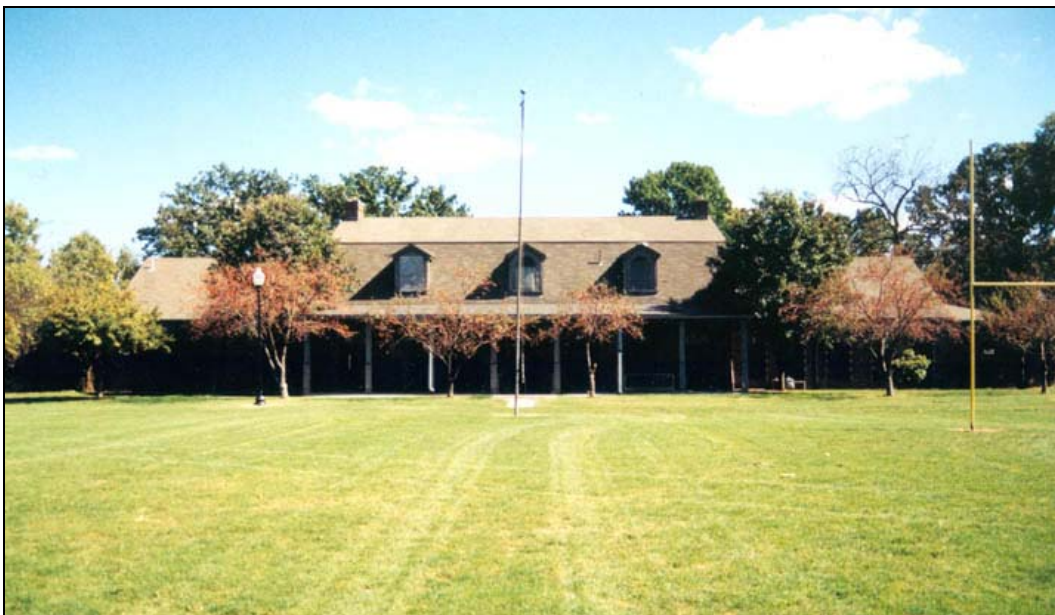
**Figure V.16** Now called the Garfield Arts Center, the structure looks the same. The dormers have been changed slightly and flowering crabapples planted along the front. (R-V-16-HL.jpg)

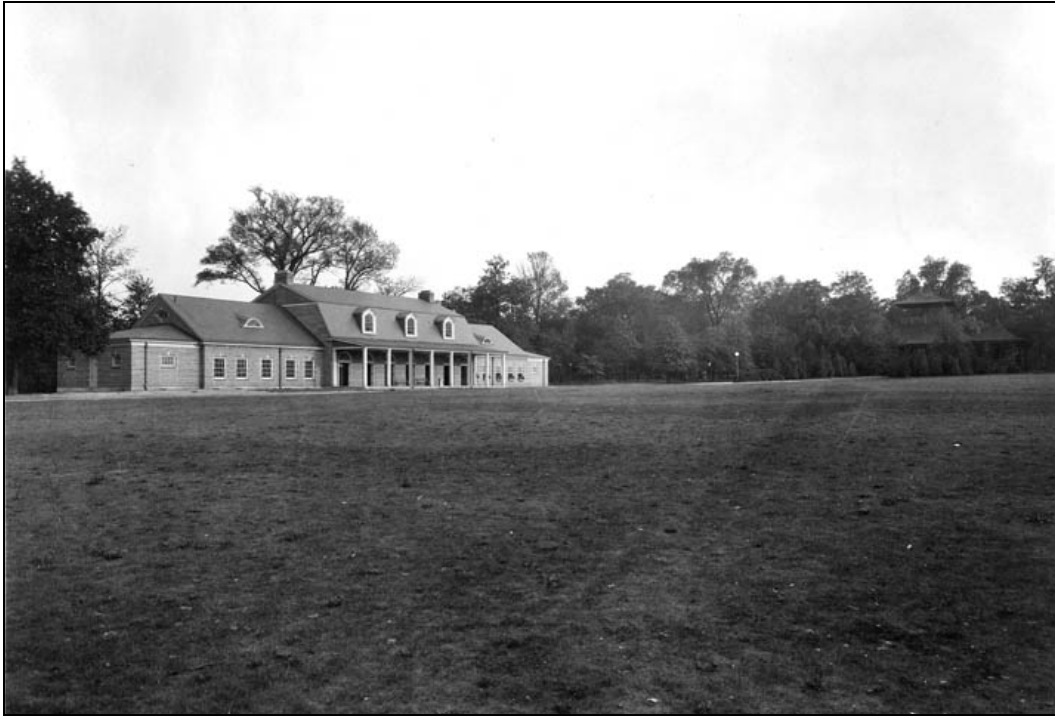
**Figure V.17** In 1922 Community House looked over the extensive playing fields as it does today. The Pagoda with a screen of cedar hedging is visible on the right. (R-PO130\_79672\_F.jpg IHS)

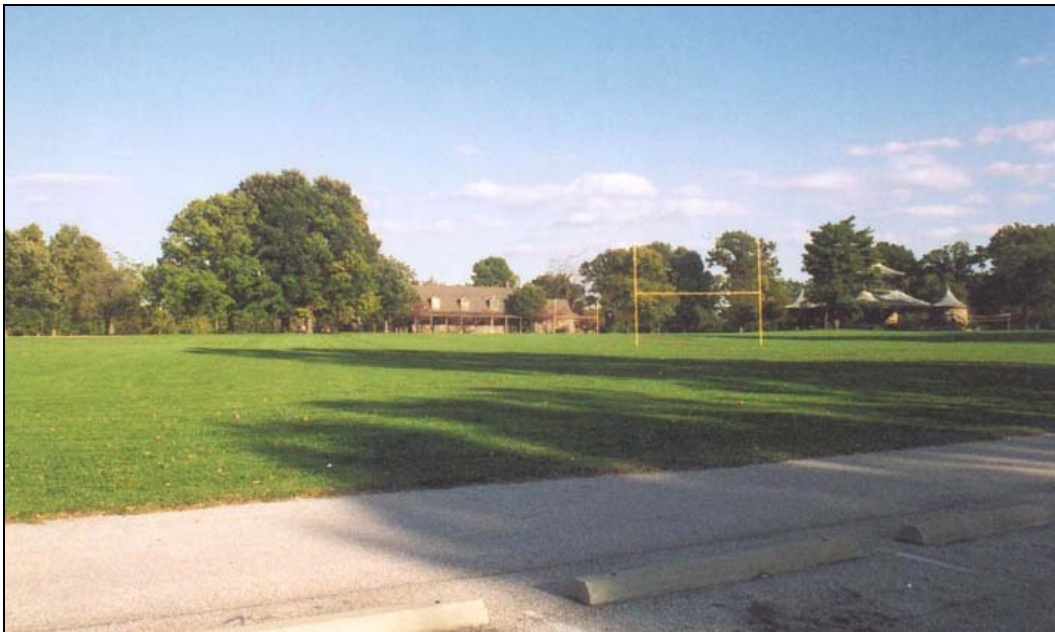
**Figure V.18** The extent of the playing fields is apparent in this 2003 view of the Garfield Arts Center. The now-mature pines by the Pagoda are visible and the parking lot in the foreground is contemporary. (R-V-18-HL.jpg)

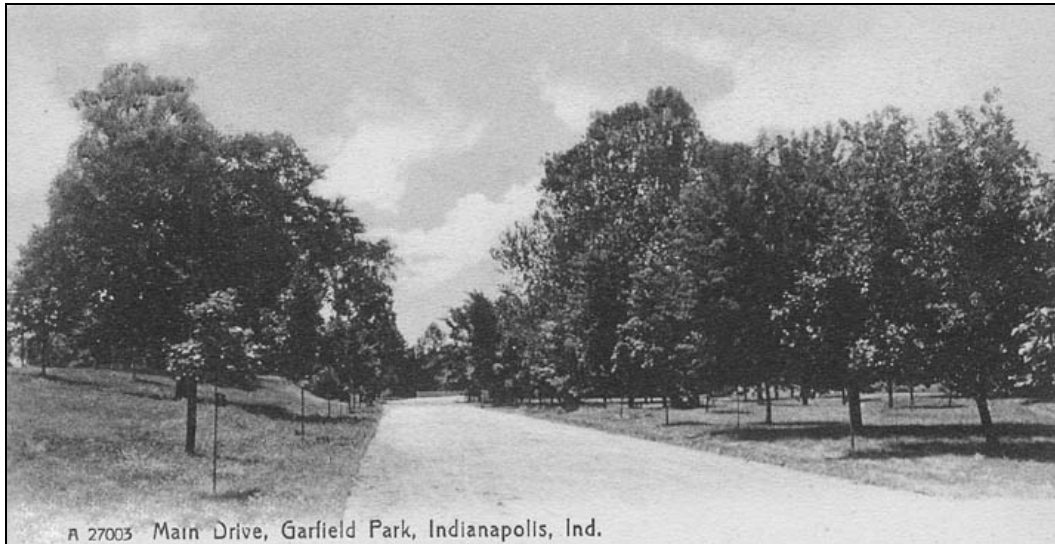
**Figure V.19** An early postcard view looking south along the wide Main Drive, (also labeled Center or Garfield Drive) which could accommodate parking. The rise of the sledding hill is on the left. Dense and varied tree planting is evident. (R-PO391\_27003.jpg IHS)

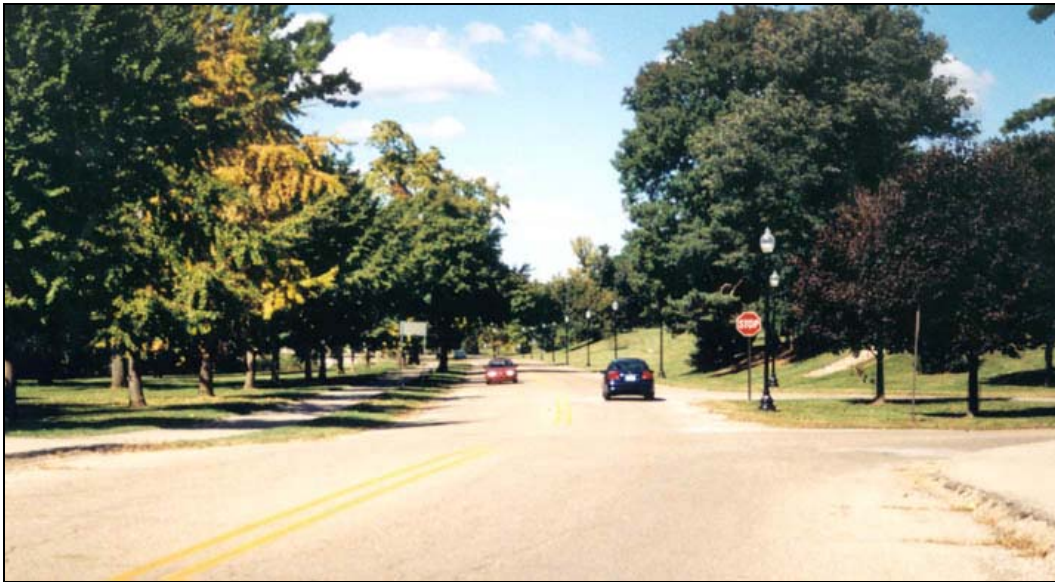
**Figure V.20** A similar view looking north in 2003 with the sledding hill rise on the right. A few of the previous trees remain and others have been planted. The drive is now known as Conservatory Drive. (R-V-20-HL.jpg)
