GARFIELD PARK CULTURAL LANDSCAPE REPORT

Chapter IV: Existing Conditions

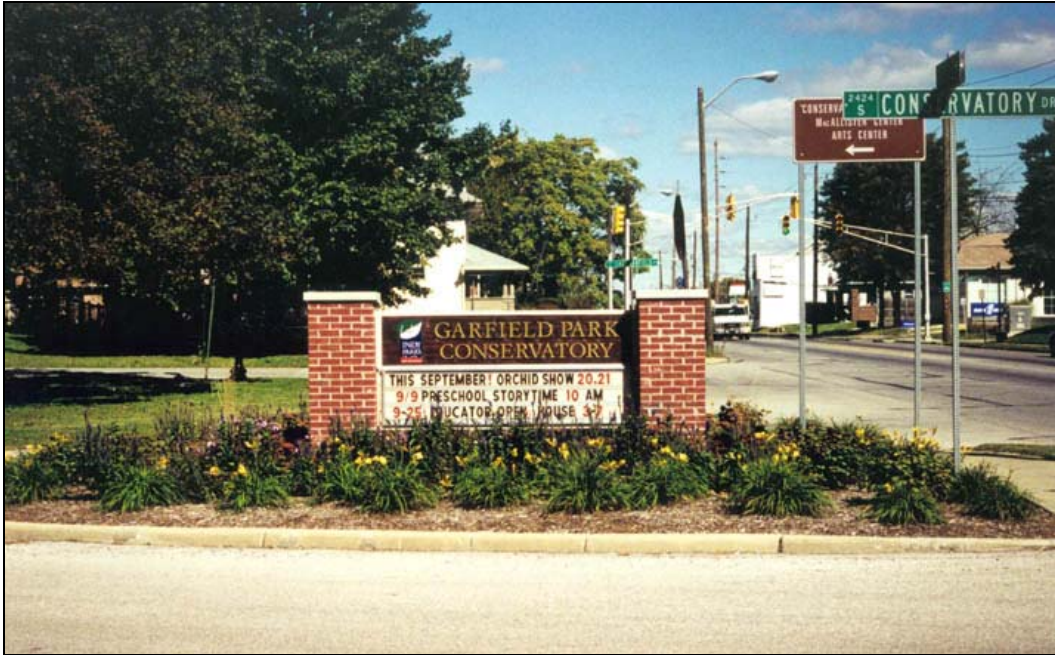
Figure IV.1 Garfield Park entry triangle at Shelby Street with contemporary signage and perennial planting. (IV-1-HL.jpg)

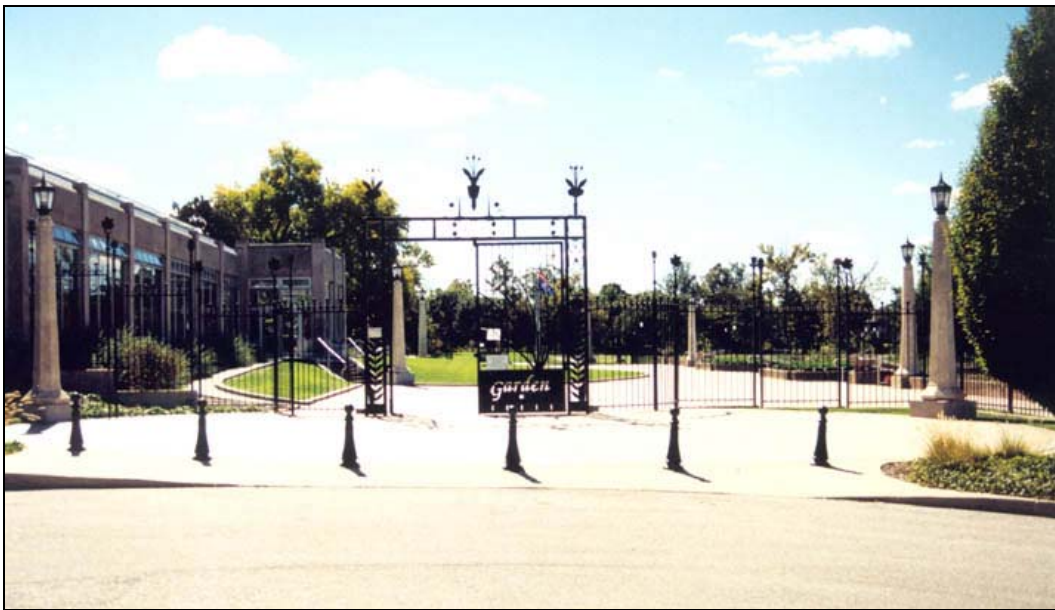
Figure IV.2 View from the Conservatory and upper terrace overlooking the Conservatory and entry area with the contemporary ornamental iron gates, iron rail fencing, and the reproduction lampposts. (R-IV-4-HL.jpg)

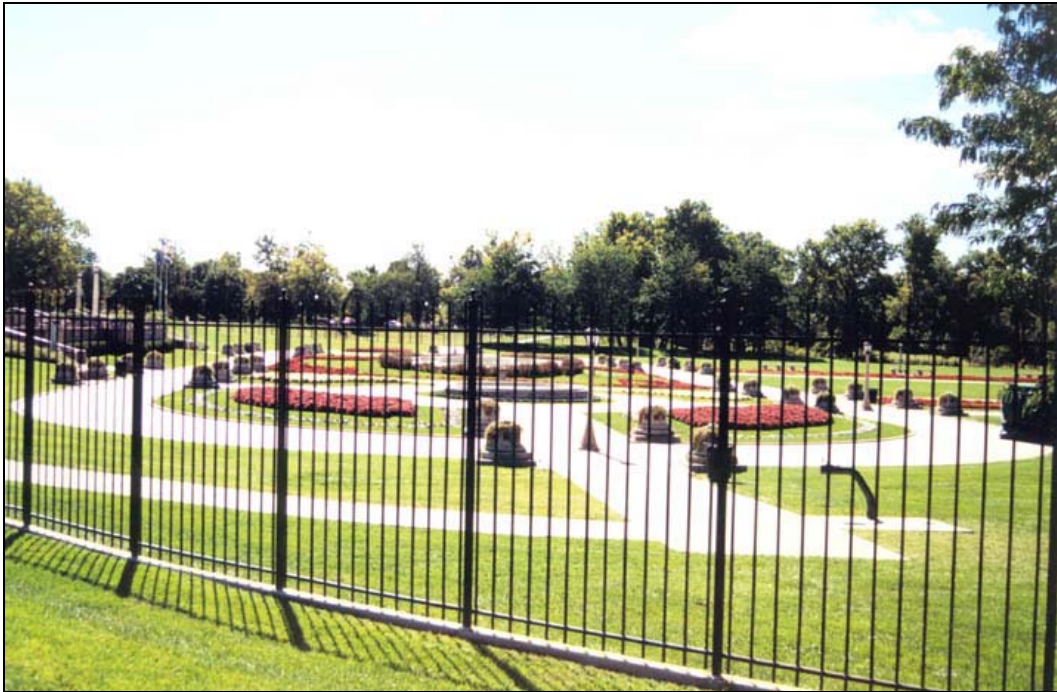
Figure IV.3 The Sunken Gardens seen from the north through the perimeter iron rail fencing. (R-IV-5-HL.jpg)

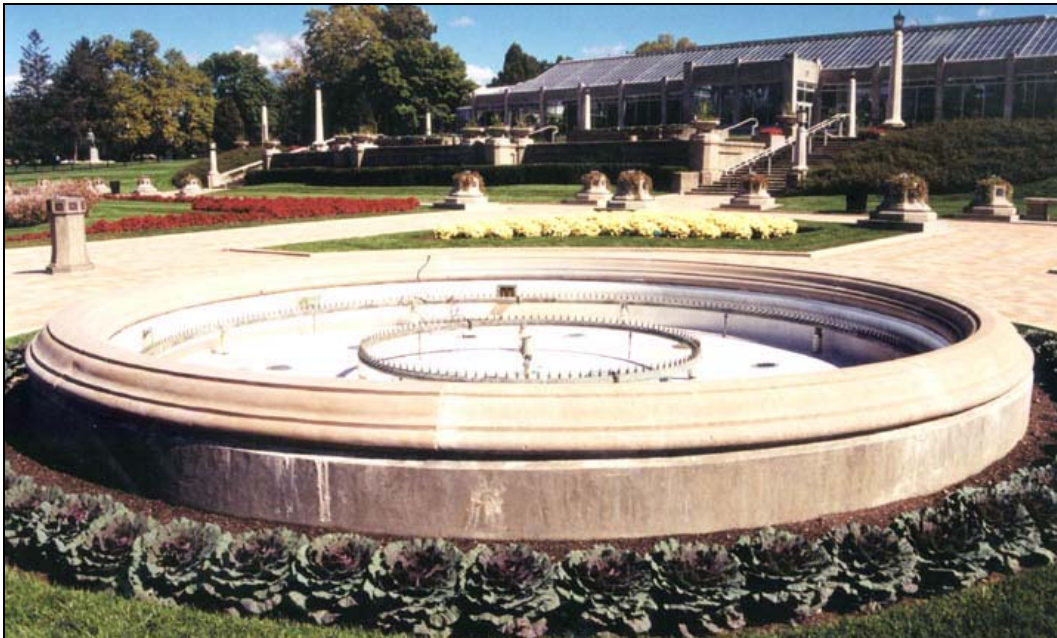
Figure IV.4 The relationship of the Overlook and Conservatory to the Sunken Gardens is seen in the background. One of the fountain basins with typical planting is in the foreground. (R-IV-8-HL.jpg)

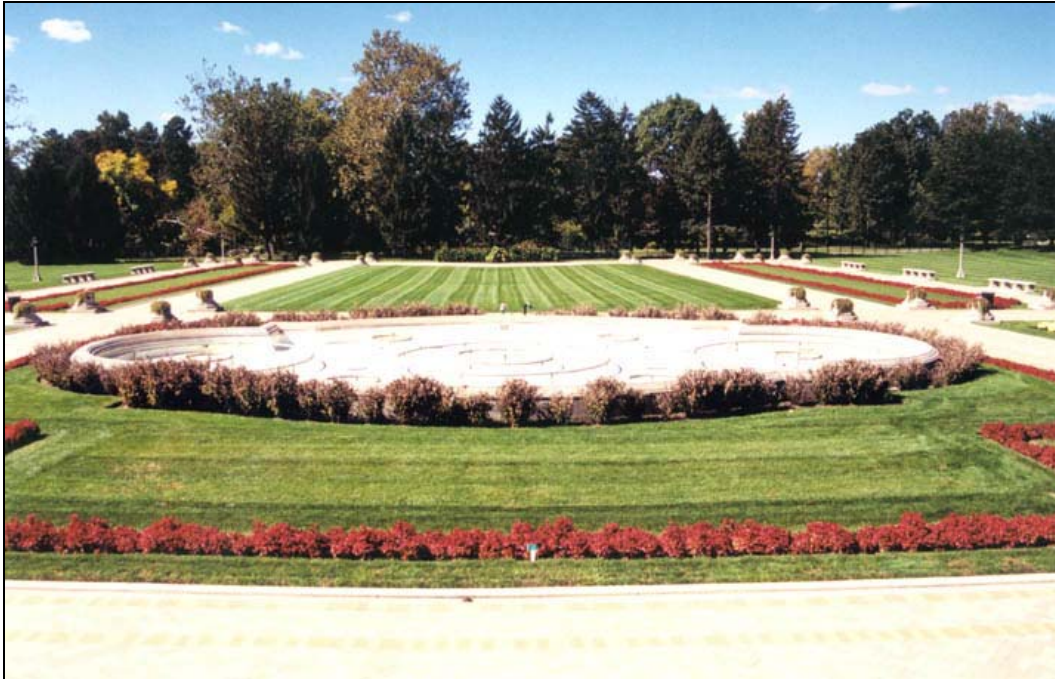
Figure IV.5 The Sunken Gardens looking west from below the Overlook, over the central fountain basin to the tree planting along Bean Creek. (R-IV-7-HL-jpg)

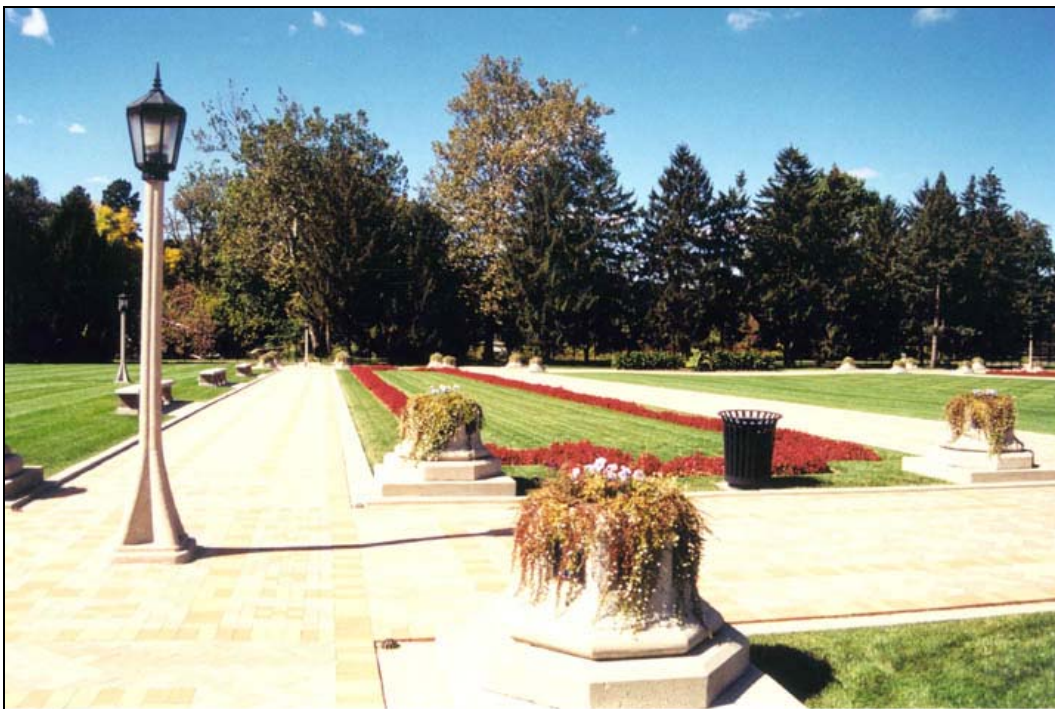
Figure IV.6 The formal, symmetrical composition of lawn panels, plantings, and walks in the Sunken Gardens with lamp posts, benches, planters, and brick walk patterns replicating the original designs. (R-IV-9-HL.jpg)

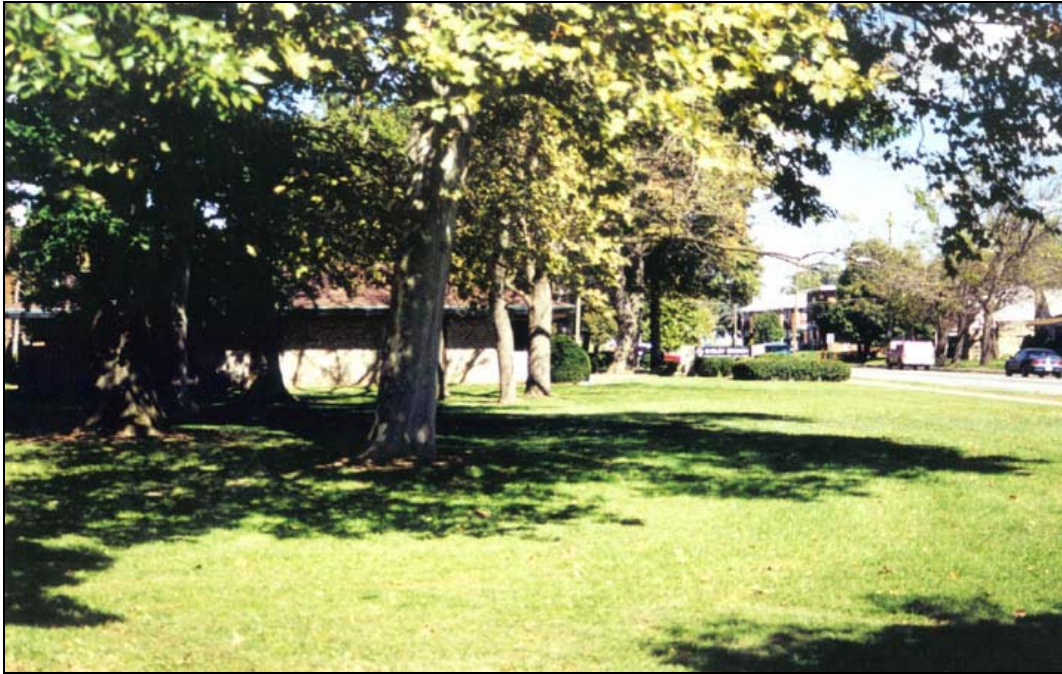
Figure IV.7 The Shelby Branch Library and surrounding park along the east perimeter with Shelby Street to the right. (R-IV-11-HL.jpg)

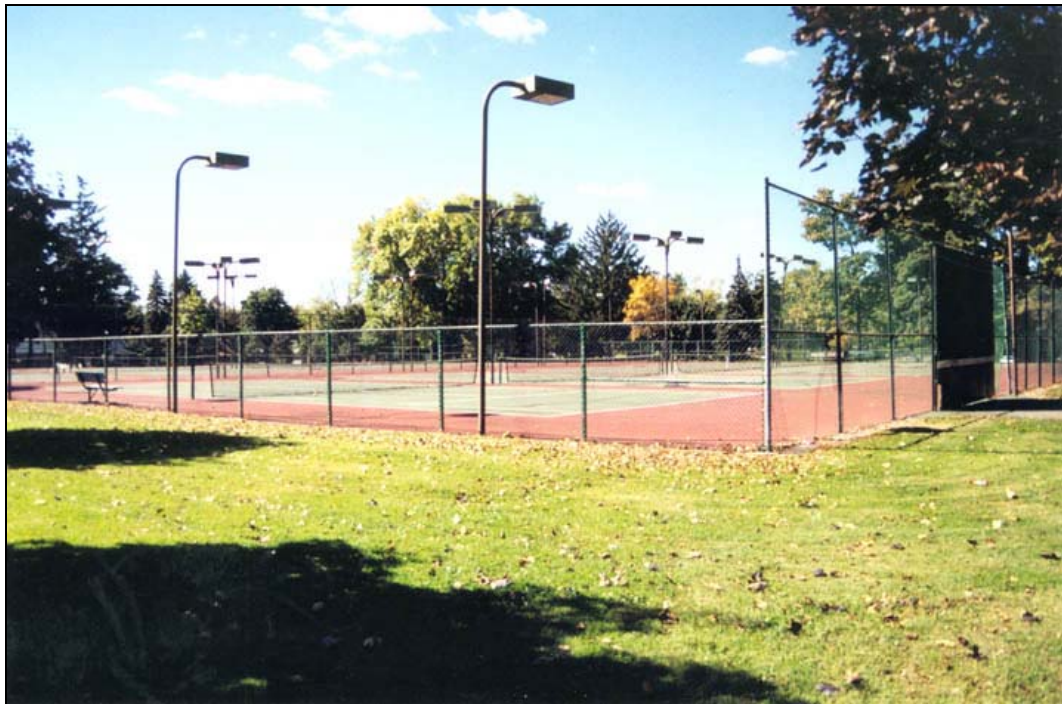
Figure IV.8 The Garfield Park tennis courts with chain link fencing and cut-off lighting. A variety of mature trees shade the surrounding lawns. (R-IV-12-HL.jpg)

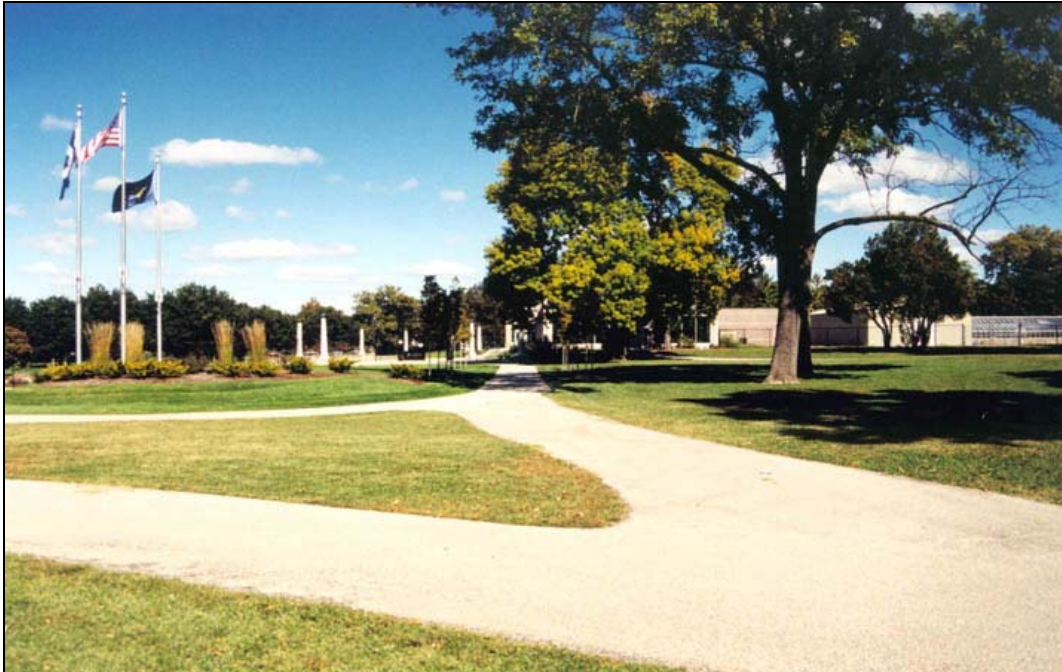
Figure IV.9 A walkway lined with young red maples is located along the former Conservatory drive with contemporary flagpoles in a planting island bed on the left. The Conservatory and greenhouse complex are in the background. (R-IV-14-HL.jpg)

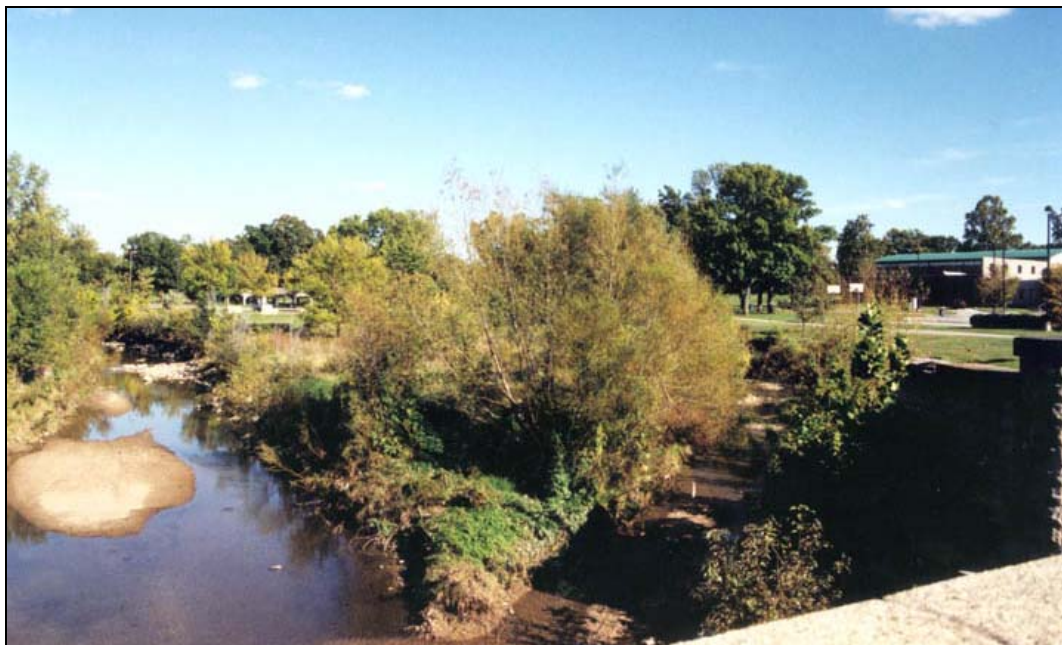
Figure IV.10 Stream corridors and vegetation along Pleasant Run (left) and Bean Creek (right) seen from the Pagoda Drive bridge with Burrello Center in the background. (R-IV-15-HL.jpg)

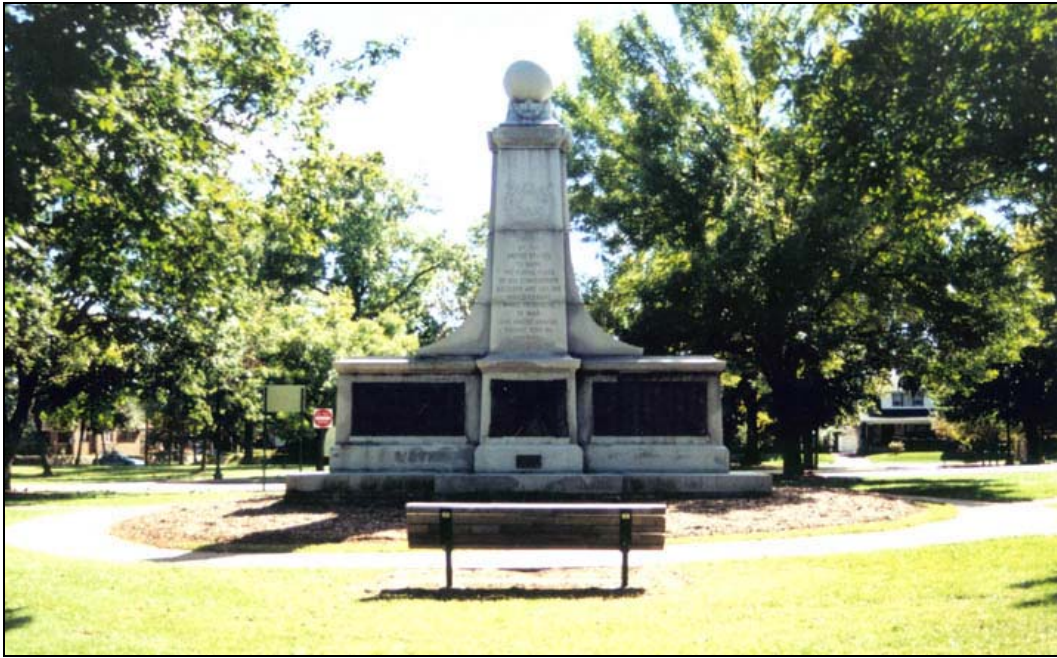
Figure IV.15 Confederate Prisoners of War Memorial with circular walk and bench surrounded by characteristic landscape pattern of lawn and trees. (R-IV-24.HL.jpg)

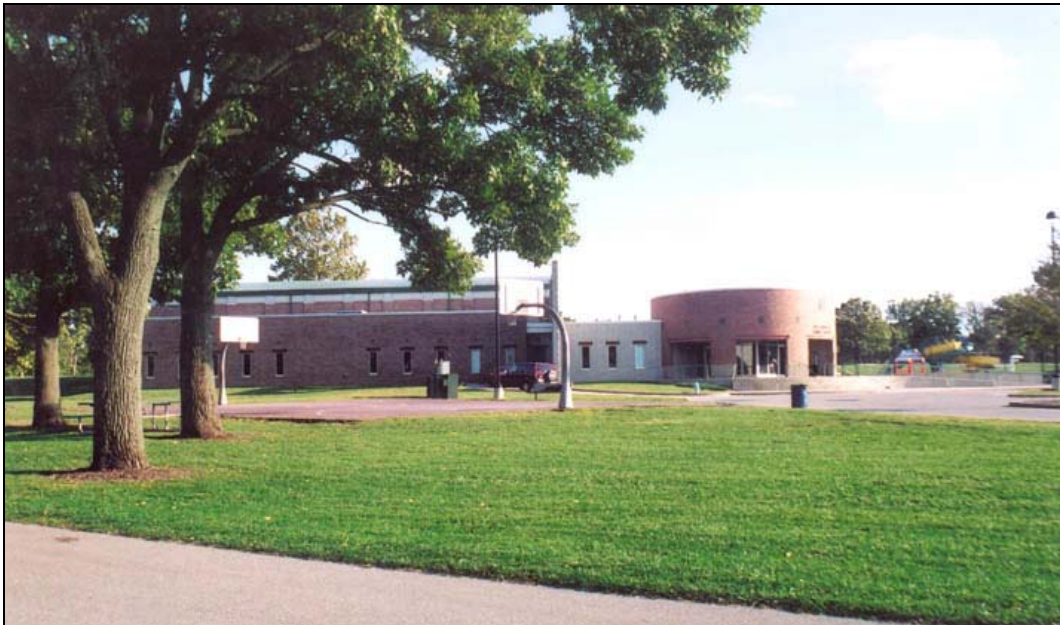
Figure IV.16 Burrello Family Center area with basketball court, playgrounds, parking, lawn, and mature trees. (R-IV-25-HL.jpg)

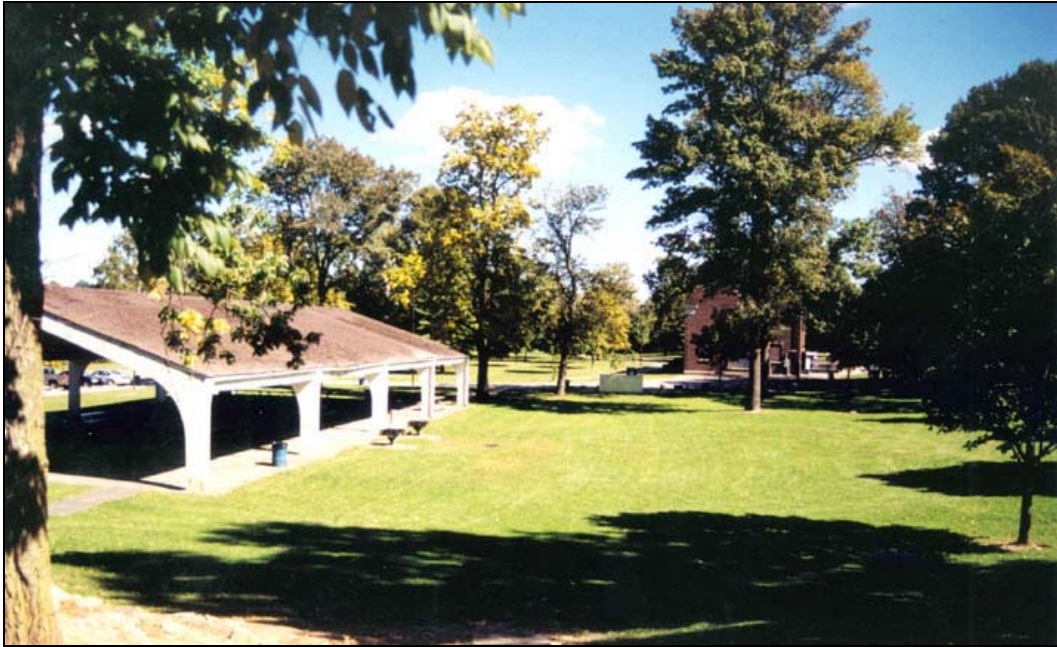
Figure IV.17 Contemporary Corporate Pavilion surrounded by lawn, north of the MacAllister Center for Performing Arts. (R-IV-26_HL.jpg)

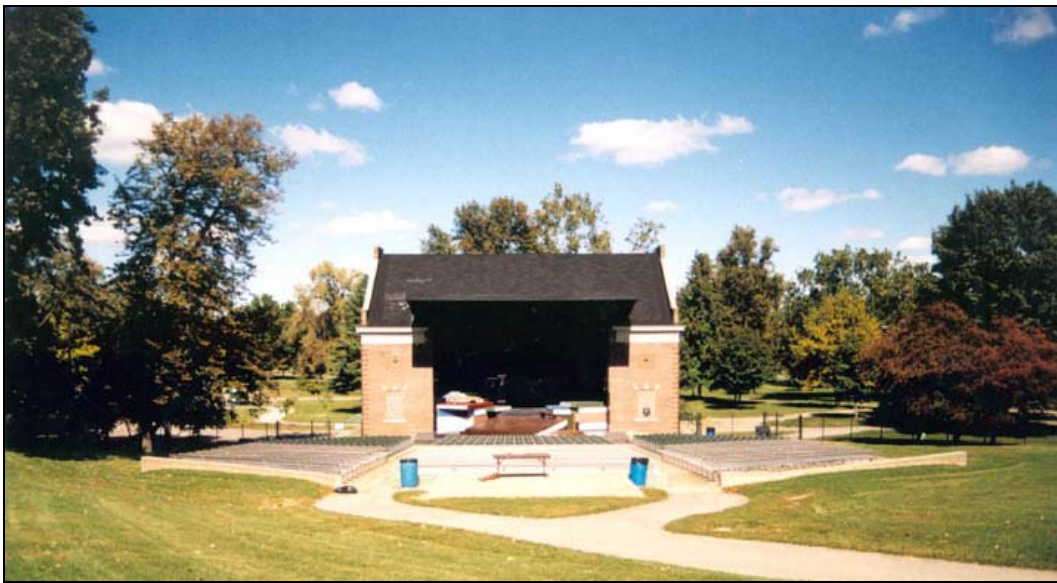
Figure IV.18 The MacAllister Center for Performing Arts is an open-air amphitheater with fixed and lawn seating, having an audience capacity of about three thousand. (R-IV-27-HL.jpg)

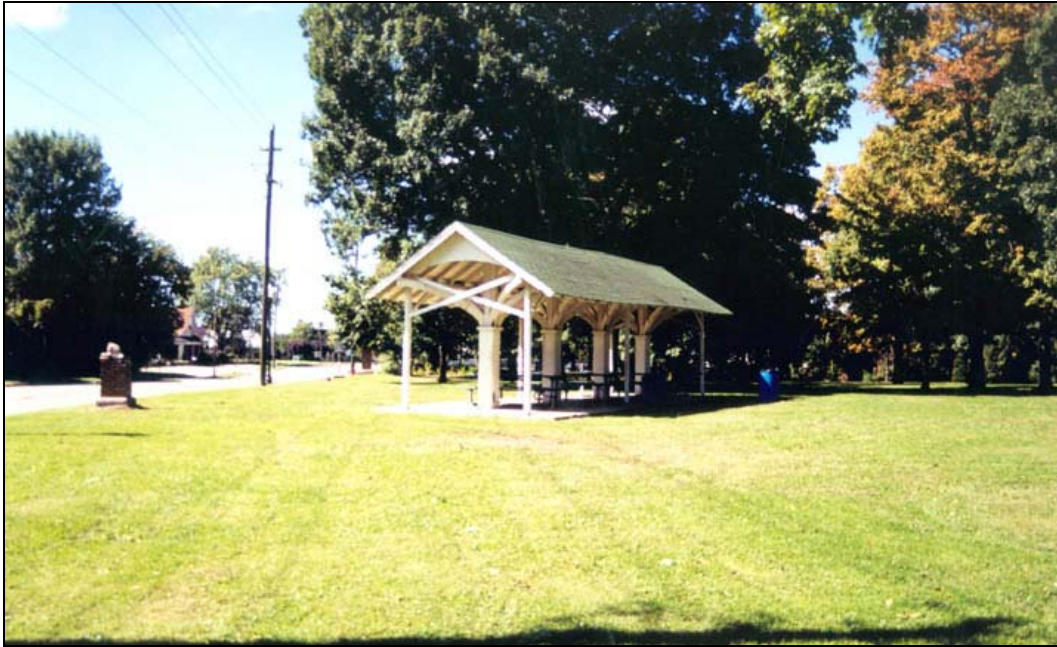
Figure IV.19 Located along Southern Avenue, the streetcar shelter built in 1905 is used as a picnic shelter. On the left is one of the masonry piers marking the streetcar turning loop. (R-IV-29_HL.jpg)

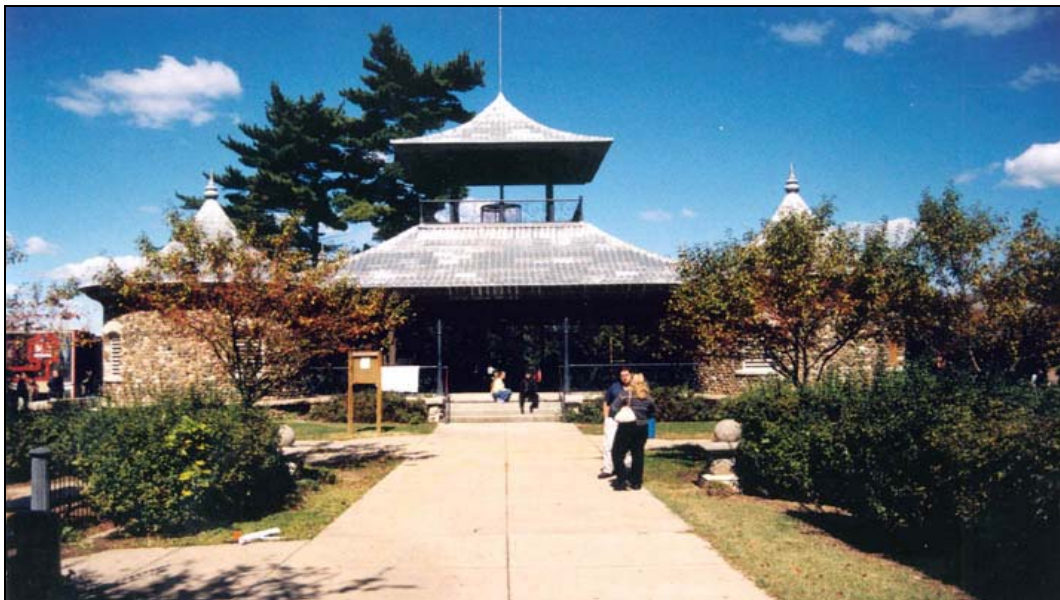
Figure IV.20 Restored Pagoda with surrounding plantings and the contemporary garden of a park playground. (R-IV-30_HL.jpg)

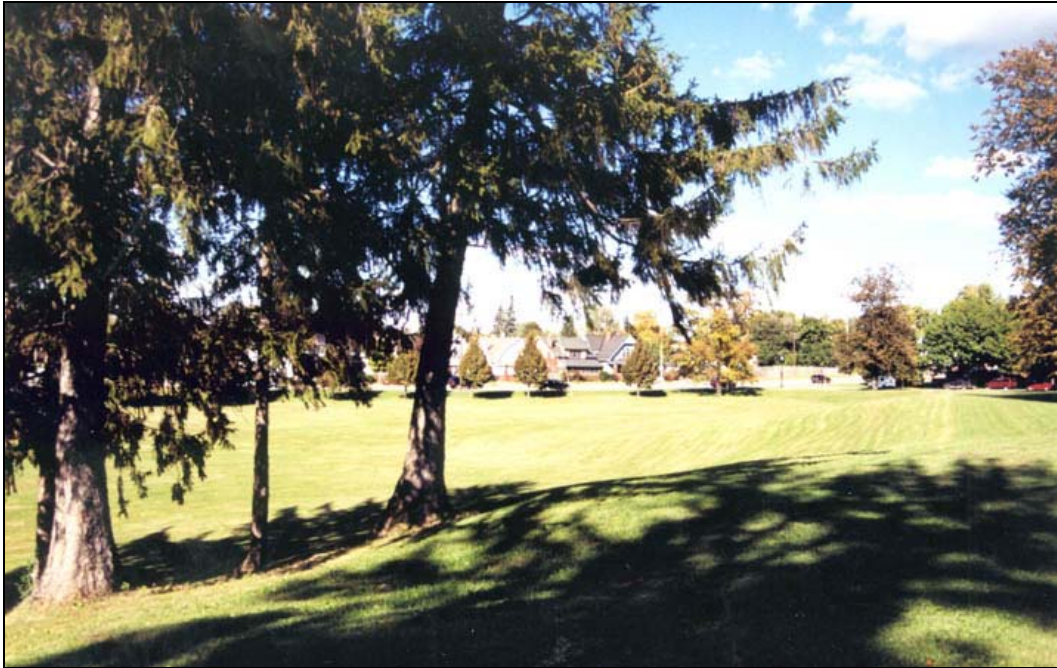
Figure IV.21 The open landscape of the sledding hill with a group of spruce trees. In the background is a formal line of trees along the park boundary.
(R-IV-33_HL.jpg)

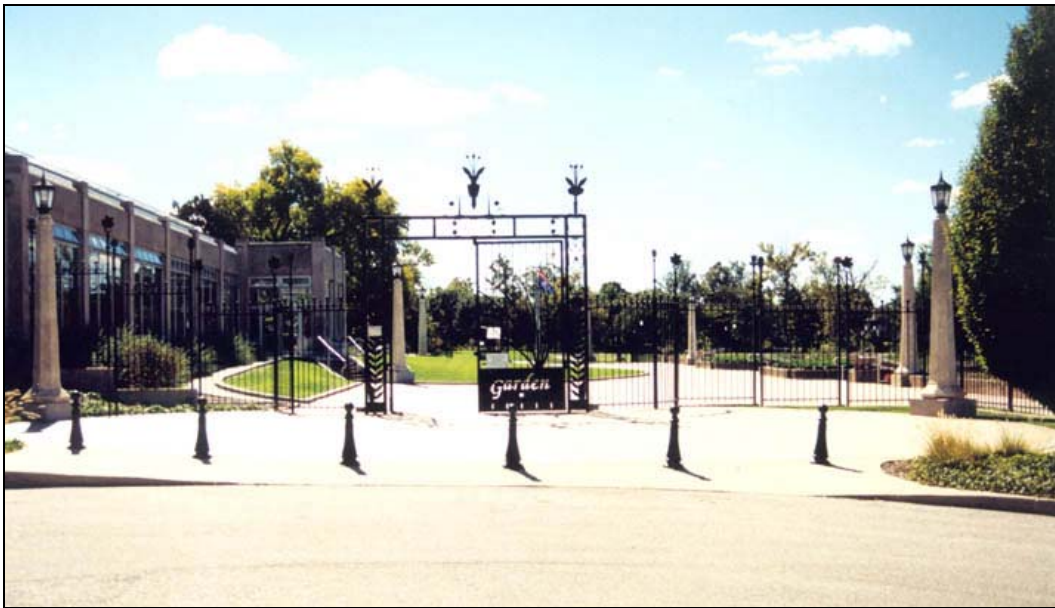
Figure IV.2 View from the Conservatory and upper terrace overlooking the Conservatory and entry area with the contemporary ornamental iron gates, iron rail fencing, and the reproduction lampposts. (R-IV-4-HL.jpg)

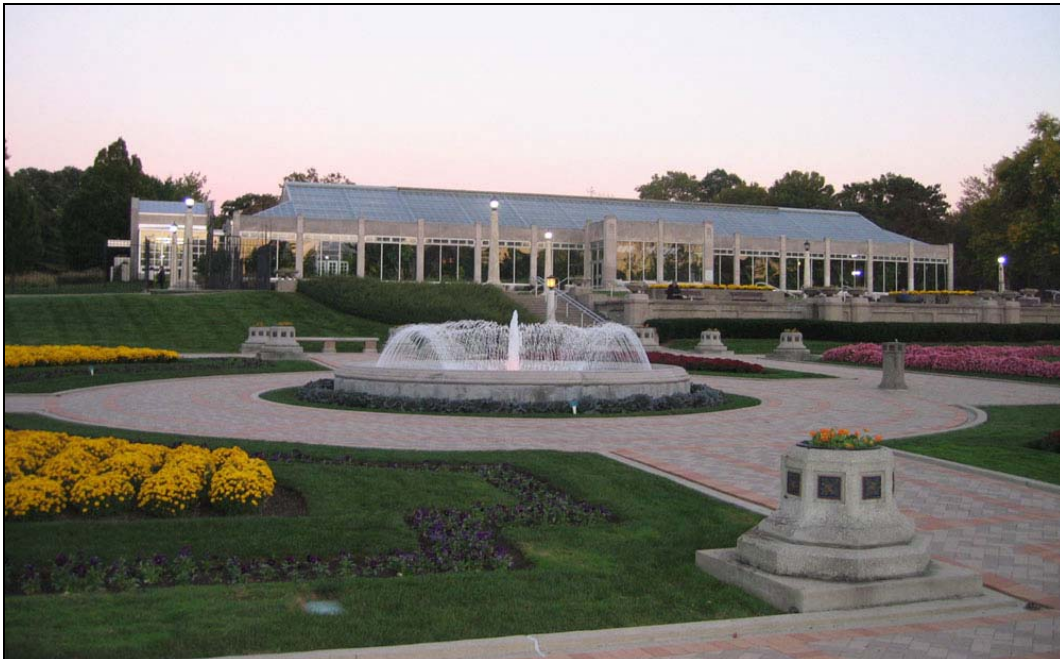
Figure IV.4 In this twilight view garden details and grade changes are apparent with the lower garden and the higher Overlook and Conservatory. One fountain with typical planting is in the foreground. (R-IV-cons-ftn-HL.jpg)

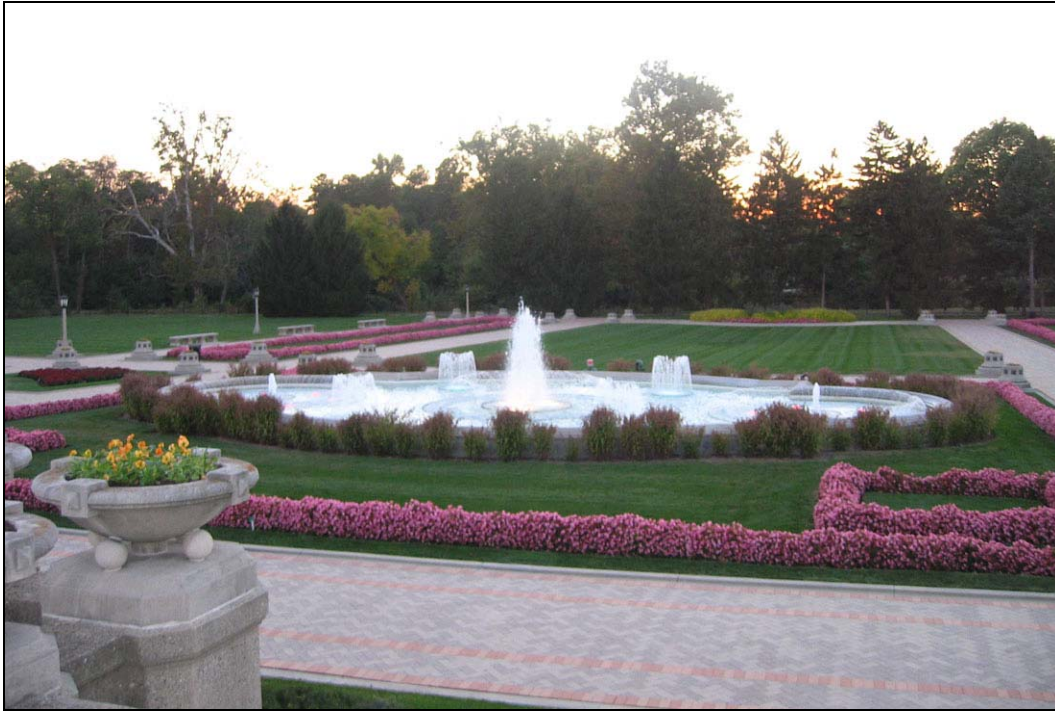
Figure IV.5 The Sunken Gardens looking west from the Overlook, over the central fountain basin to the tree planting along Bean Creek. (R-IV-7-HL.jpg)

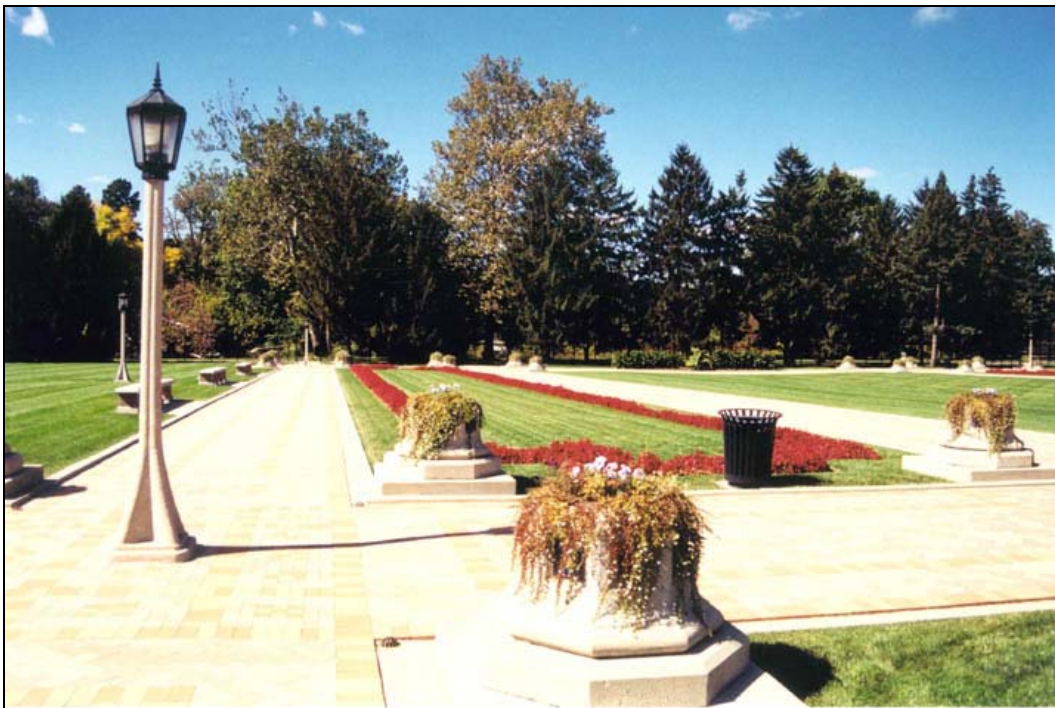
Figure IV.6 The formal, symmetrical composition of lawn panels, plantings, and walks in the Sunken Gardens. Light posts, benches, planters, and brick walk patterns replicate the character and details of the original design. (R-IV-9-HL.jpg)

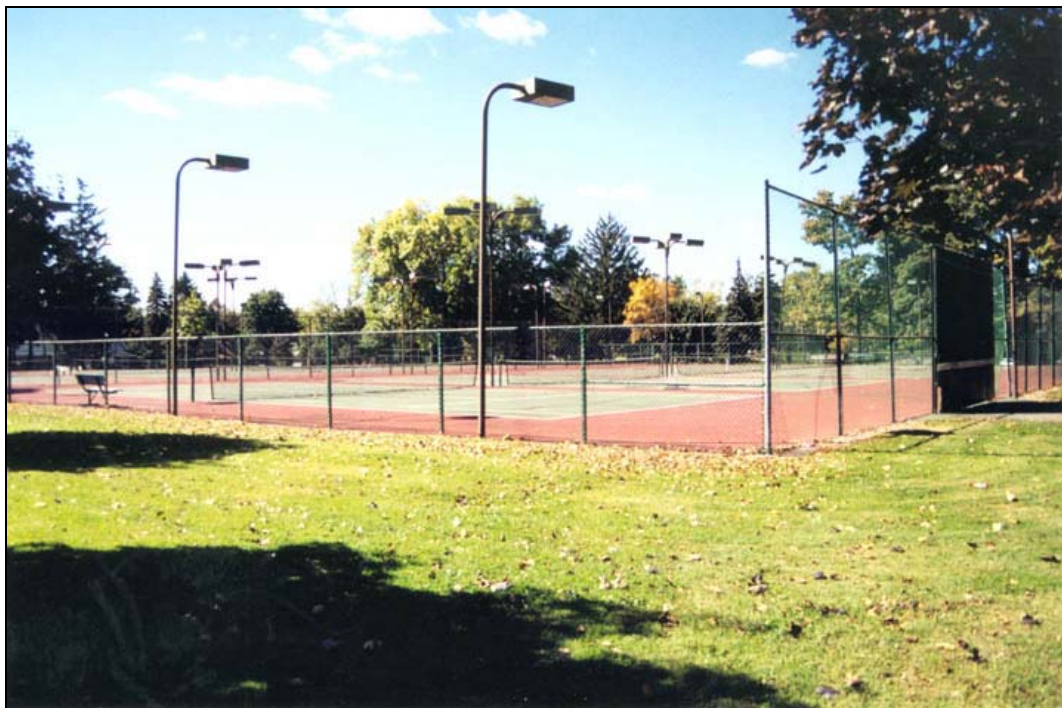
Figure IV.8 The Garfield Park tennis courts with chain link fencing and cut-off lighting. A variety of mature trees shade the surrounding lawns. (R-IV-12-HL.jpg)

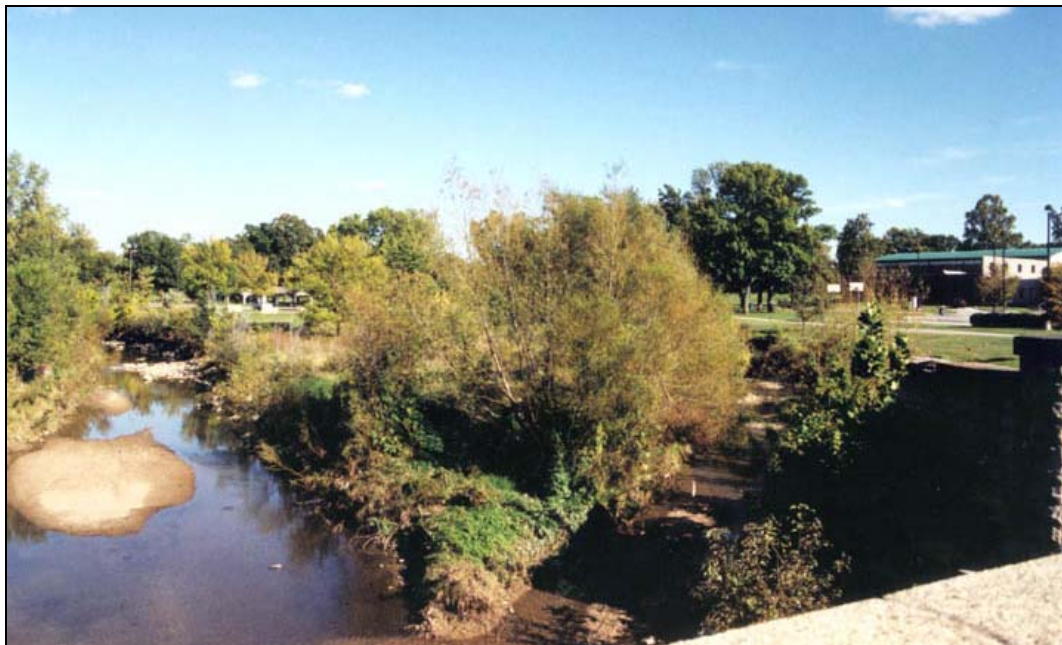
Figure IV.10 Stream corridors and vegetation along Pleasant Run (left) and Bean Creek (right) seen from the Pagoda Drive bridge with Burrello Center in the background. (R-IV-15-HL.jpg)

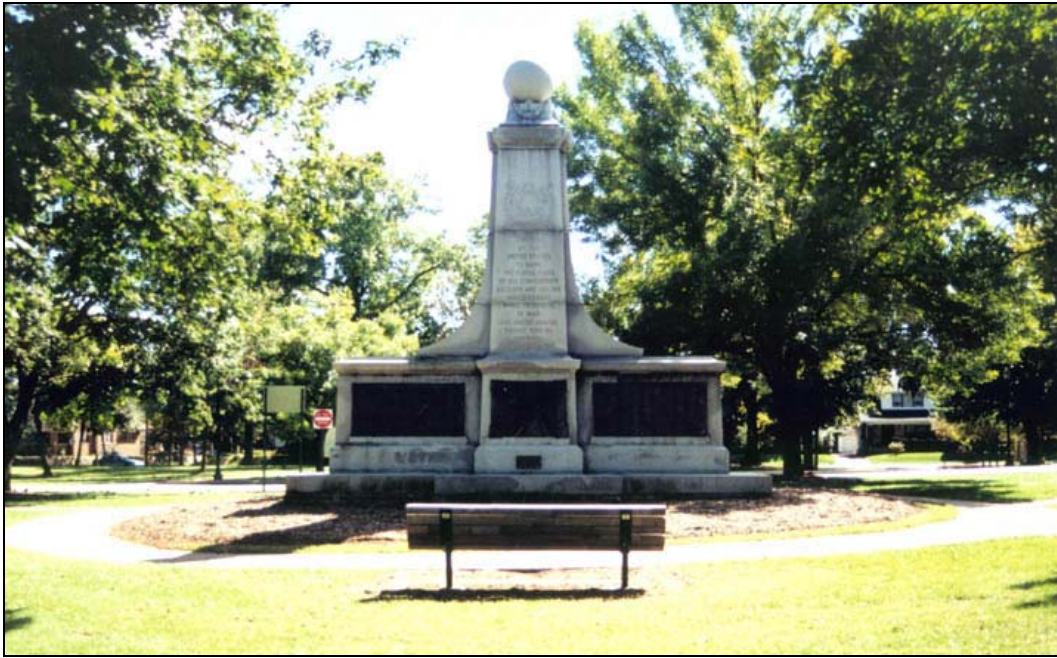
Figure IV.15 Confederate Prisoners of War Memorial with circular walk and bench surrounded by characteristic landscape pattern of lawn and trees. (R-IV-24.HL.jpg)

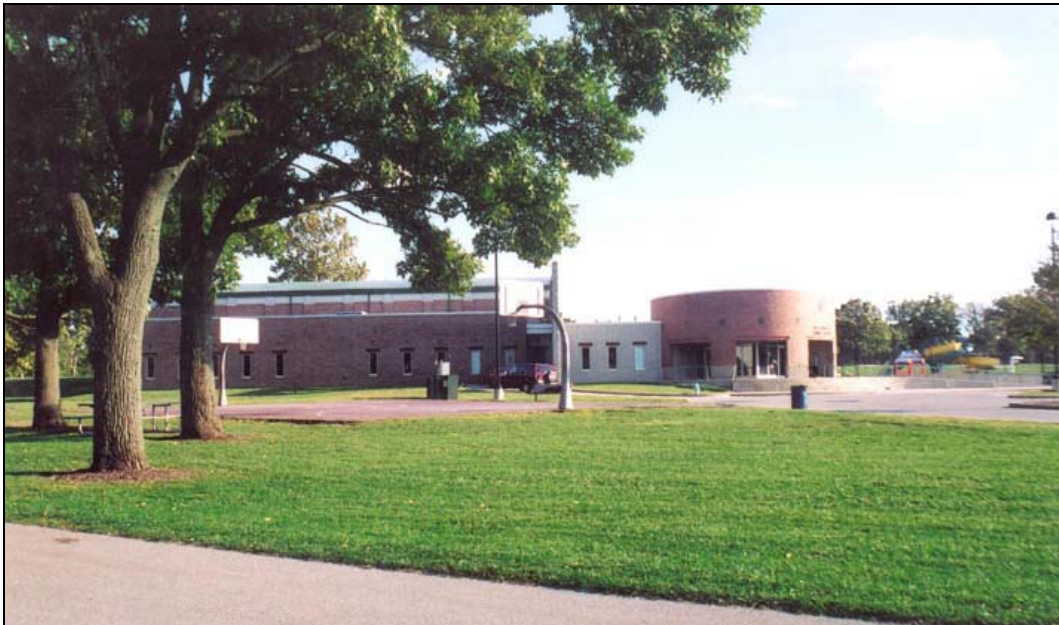
Figure IV.16 Burrello Family Center area with basketball court, playgrounds, parking, lawn, and mature trees. (R-IV-25-HL.jpg)

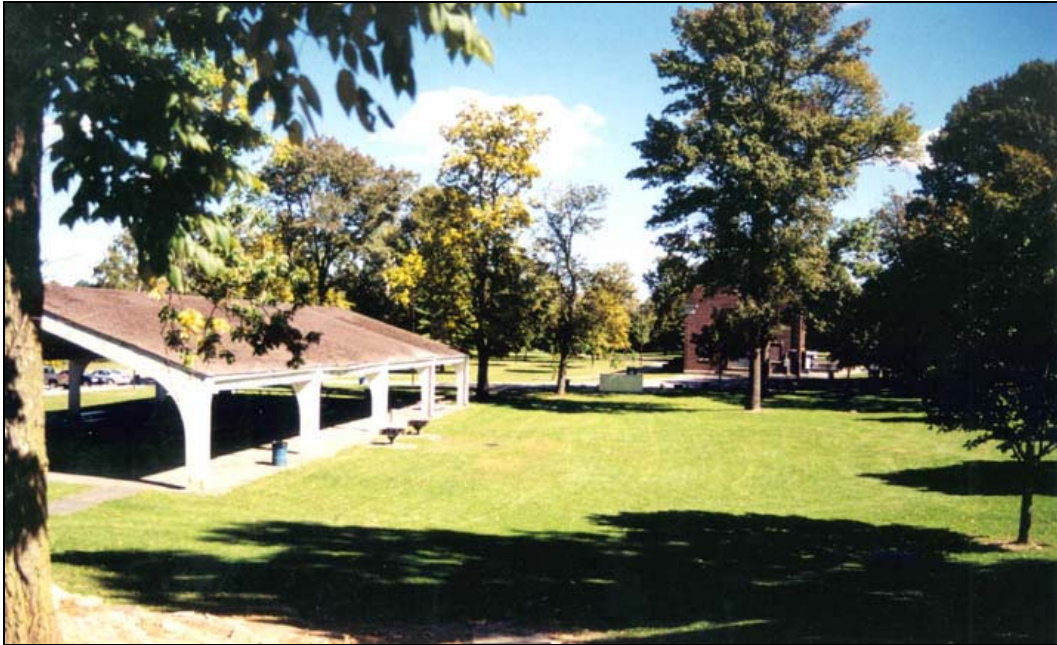
Figure IV.17 Contemporary Corporate Pavilion surrounded by lawn, north of the MacAllister Center for Performing Arts. (R-IV-26_HL.jpg)

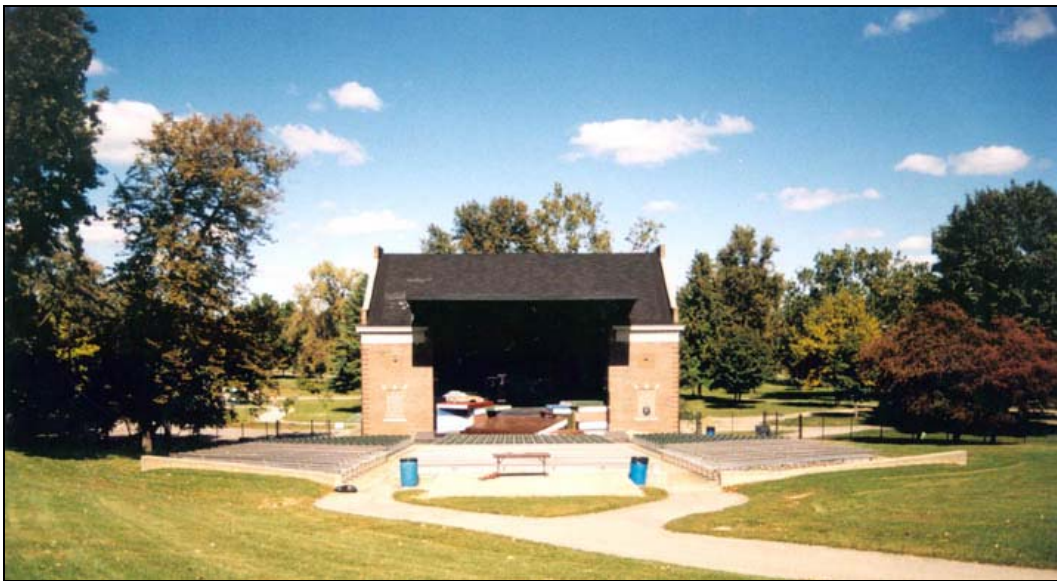
Figure IV.18 The MacAllister Center for Performing Arts is an open-air amphitheater with fixed and lawn seating, having an audience capacity of about three thousand. (R-IV-27-HL.jpg)

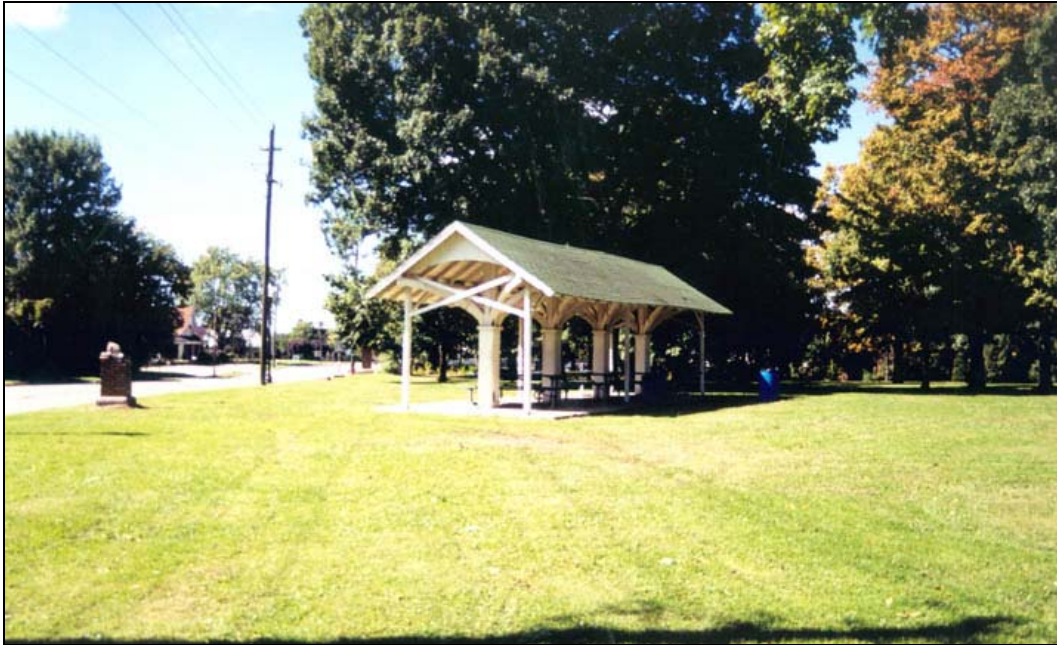
Figure IV.19 Located along Southern Avenue, the streetcar shelter built in 1905 is used as a picnic shelter. On the left is one of the masonry piers marking the streetcar turning loop. (R-IV-29_HL.jpg)

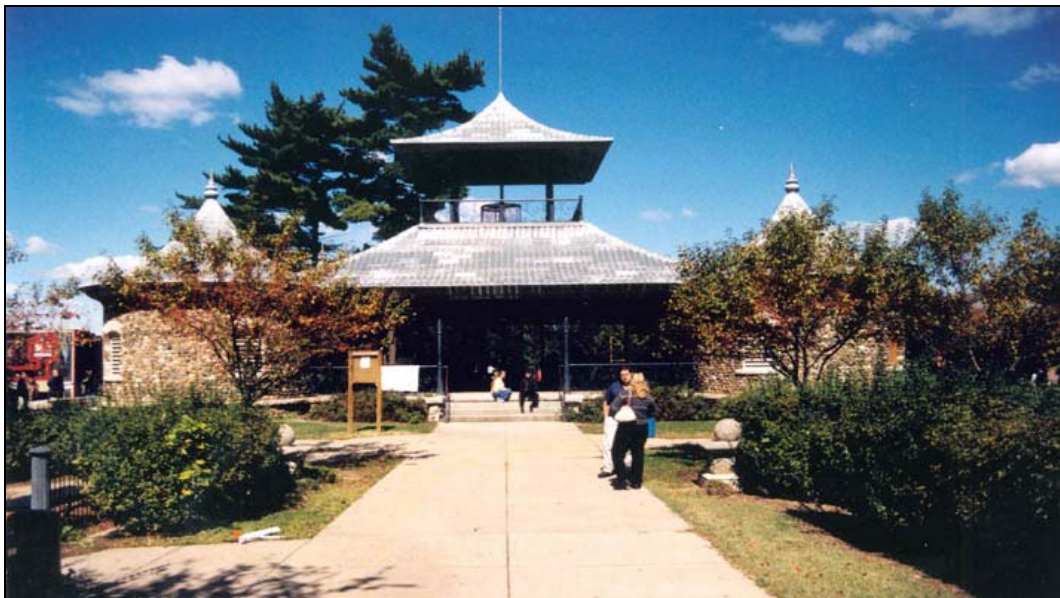
Figure IV.20 Restored Pagoda with surrounding plantings and the contemporary garden of a park playground. (R-IV-30_HL.jpg)

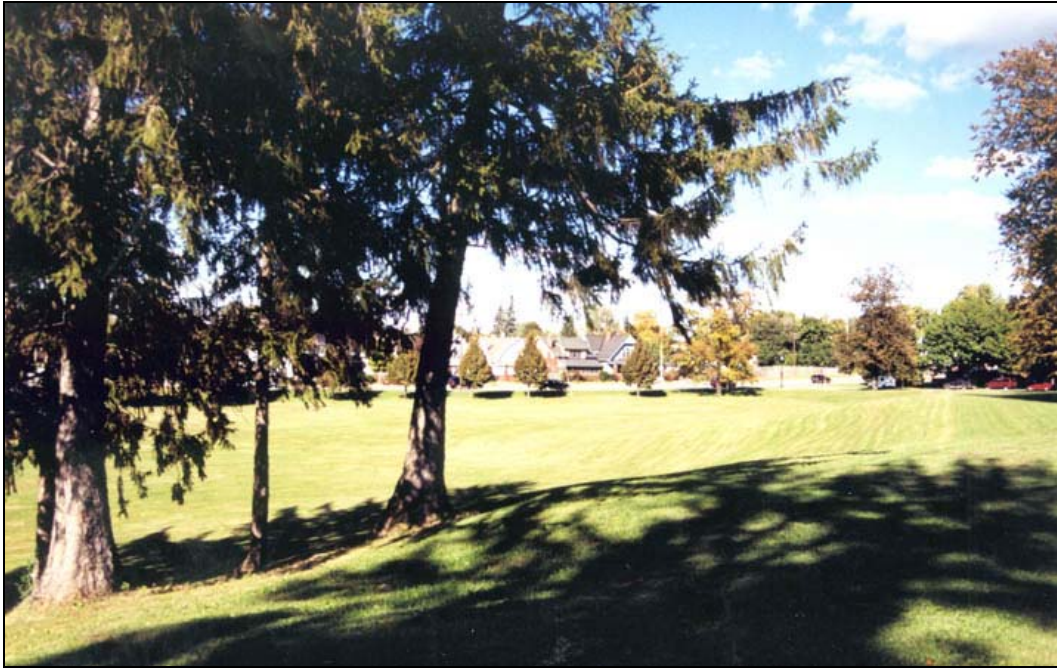
Figure IV.21 The open landscape of the sledding hill with a group of spruce trees. In the background is a formal line of trees along the park boundary.
(R-IV-33_HL.jpg)
